# Quality Inspection Report

March 2013

for Central Government  
Employees Welfare  
Housing Organisation (CGEWHO)

by Housing & Urban  
Development Corporation Ltd.,  
Consultancy Wing , Chennai

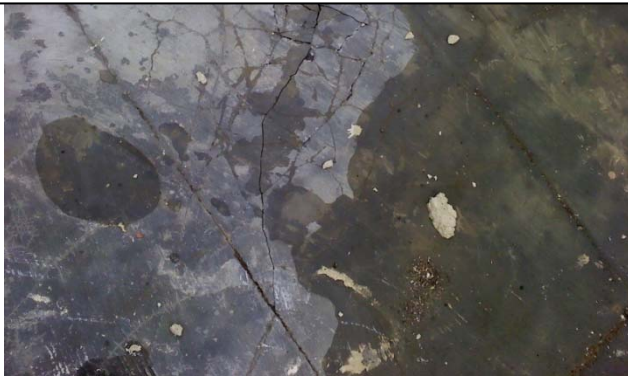
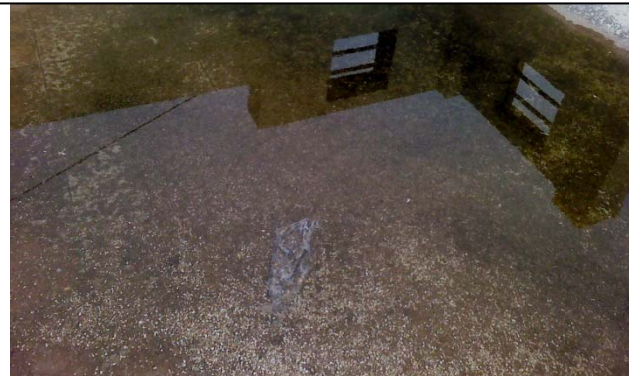
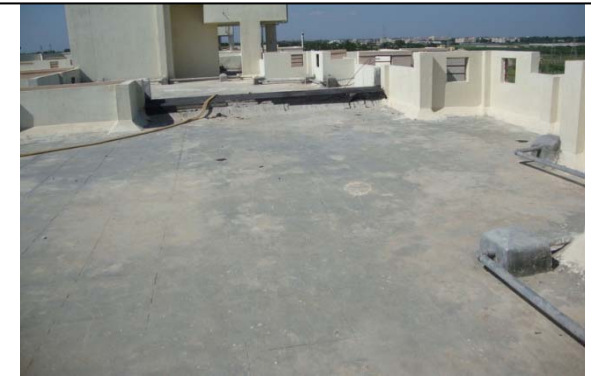
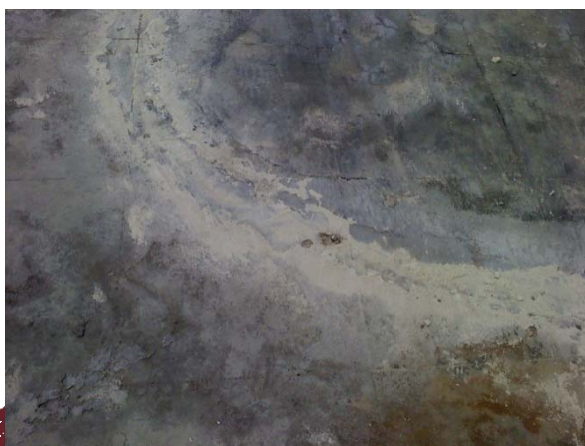
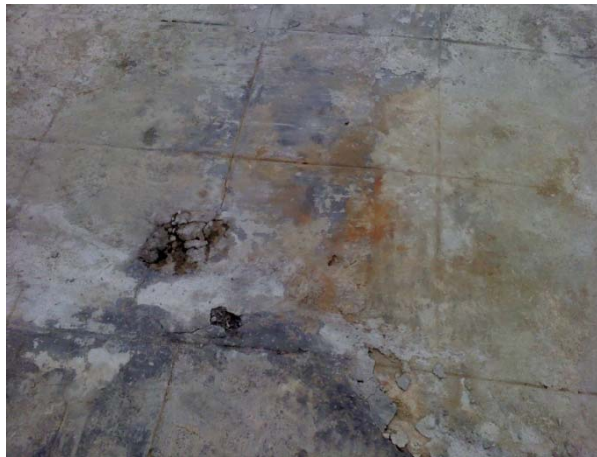
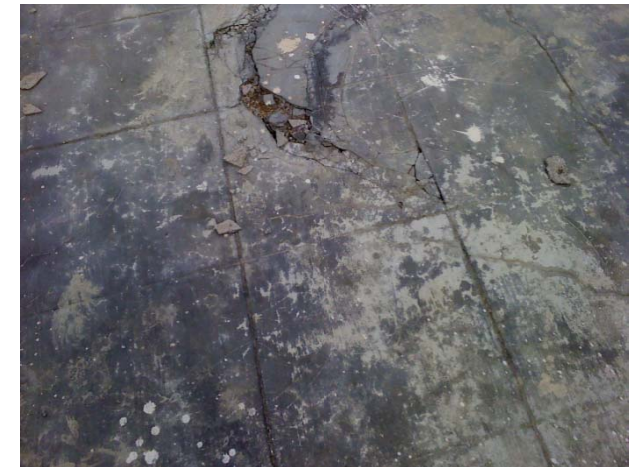
1. Water stagnation on the terrace due to undulations in most places.
2. Weather Proof course damaged and broken on most terraces which have been temporarily covered with sand and bitumen.
3. In certain blocks, expansion/construction joints are not sealed.

**Terrace : Surface finish damaged, Water stagnation, Inadequate height of Parapet wall**

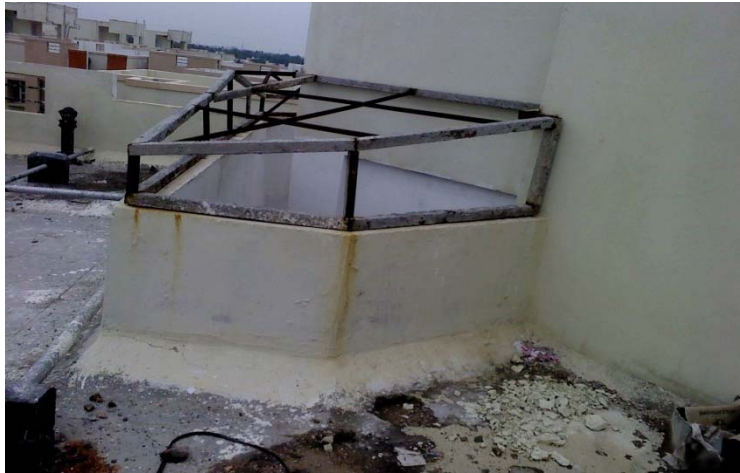
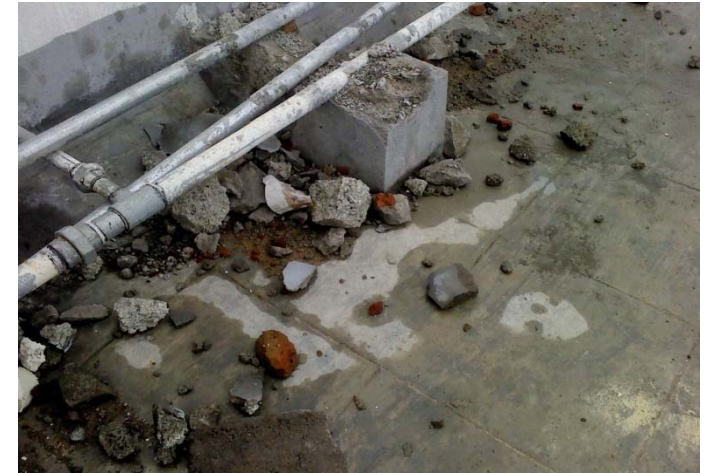
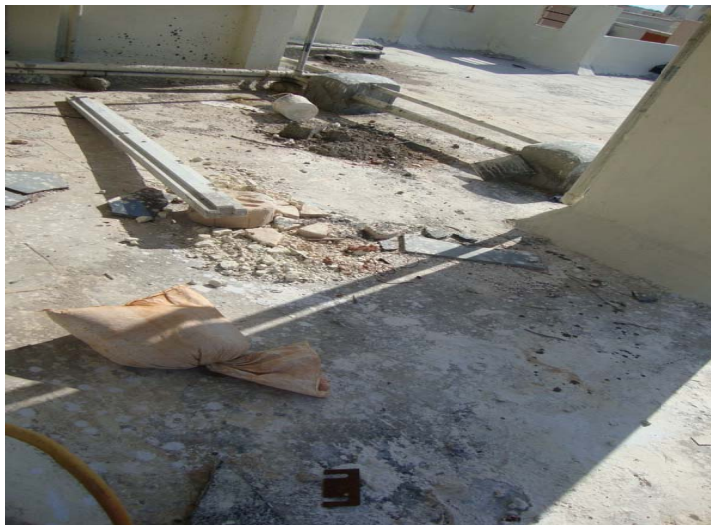
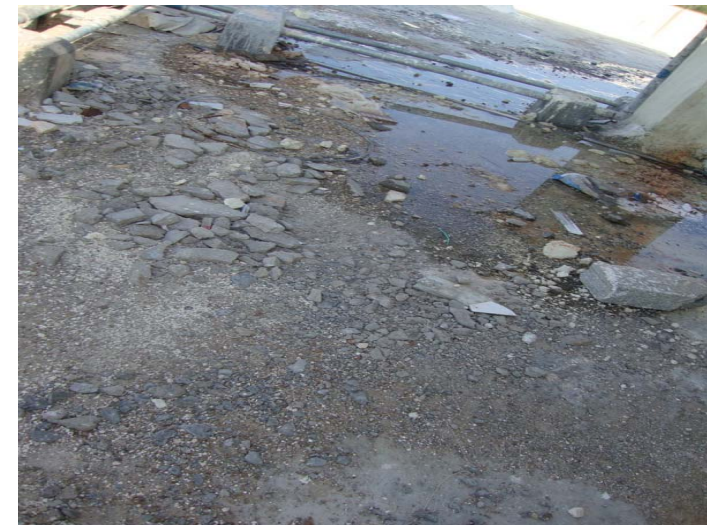
**Terrace: Malba dumped & OTS not covered and overflow pipe (WT) not connected with drain pipe**

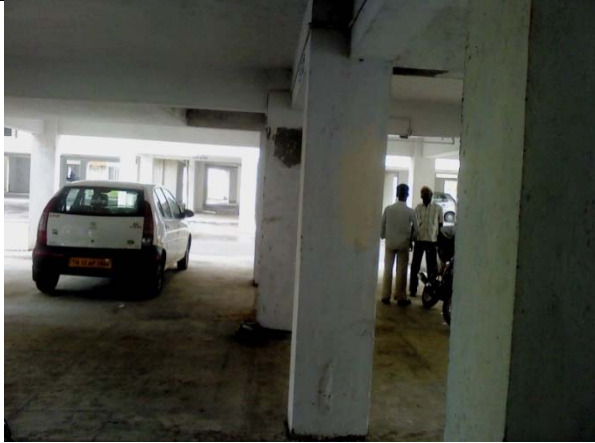
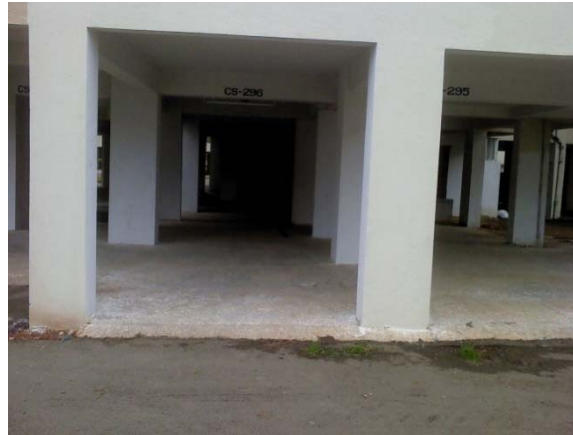
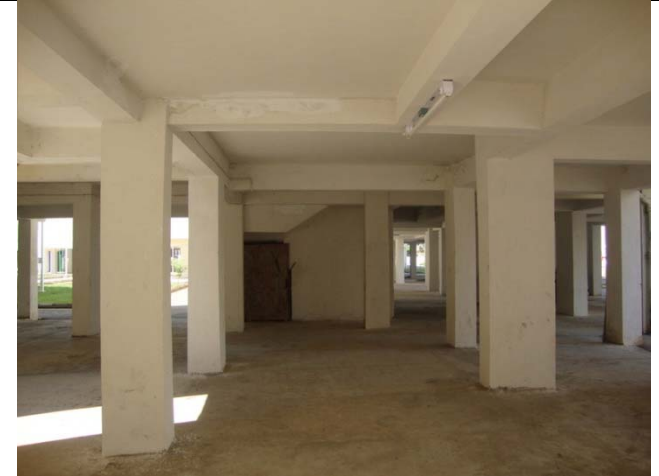
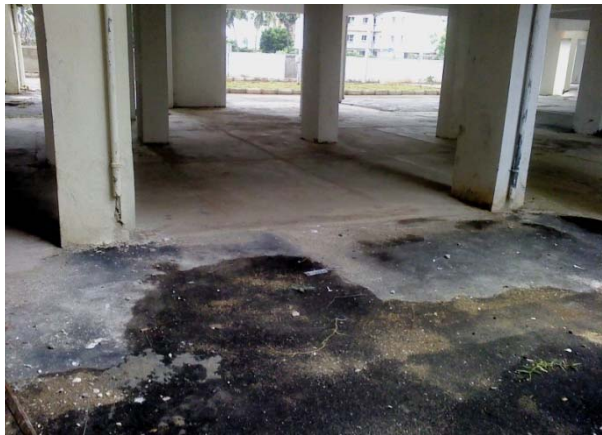
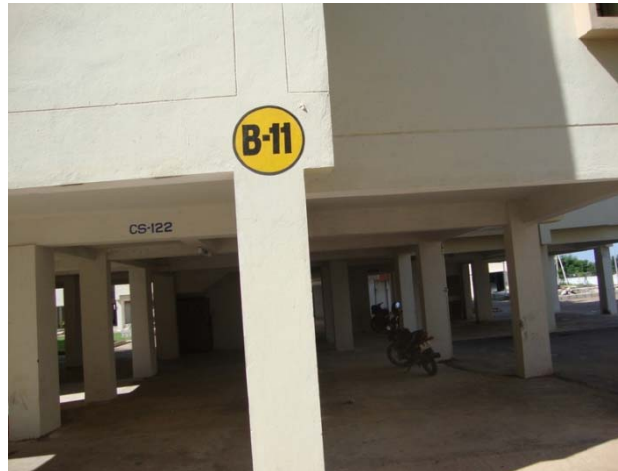
1. Columns are poorly aligned at many places.
2. Inadequate space for covered car parking and inadequate maneuvering space at many places.
3. Inadequate level difference between covered parking spaces and adjacent road surfaces.

## Stilt : Columns not aligned and inadequate parking space

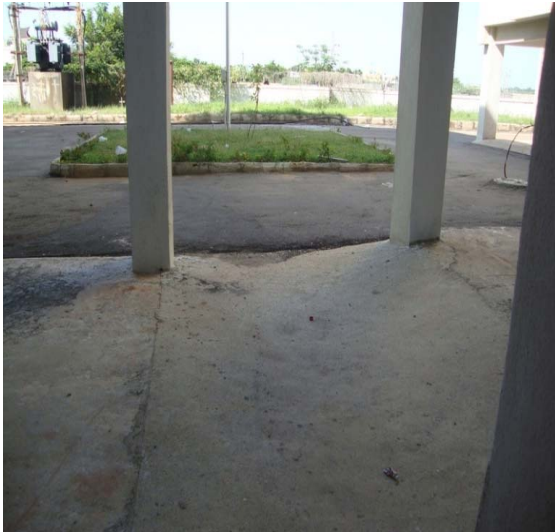
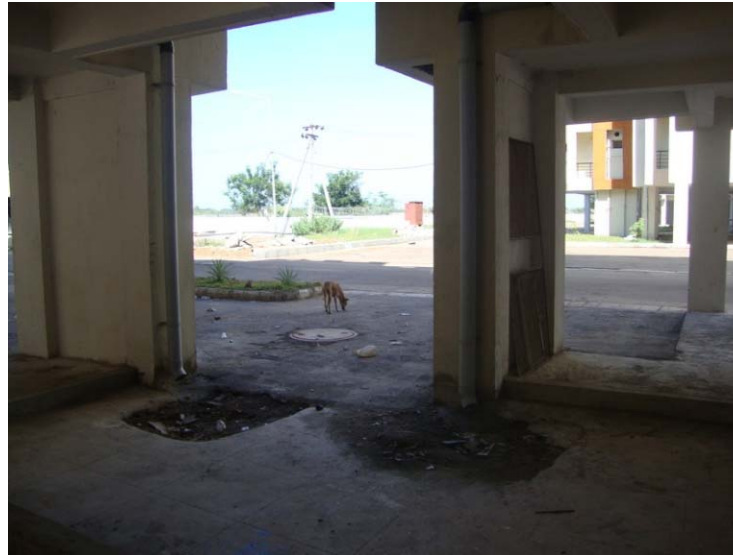
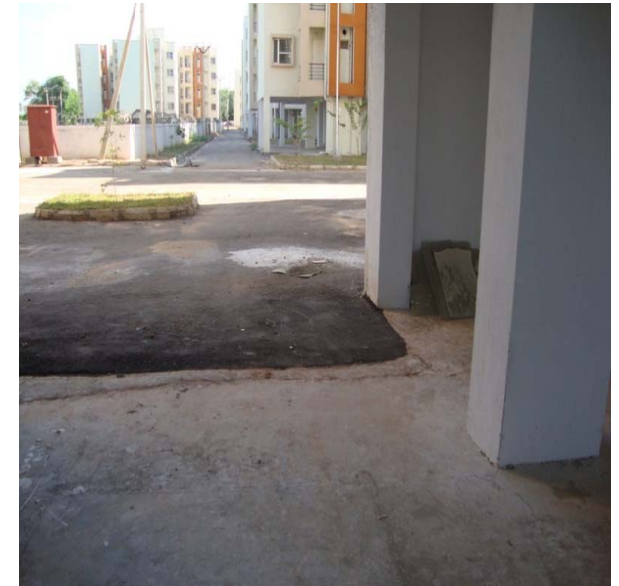
**Stilt area: Floor sloping in the wrong direction**

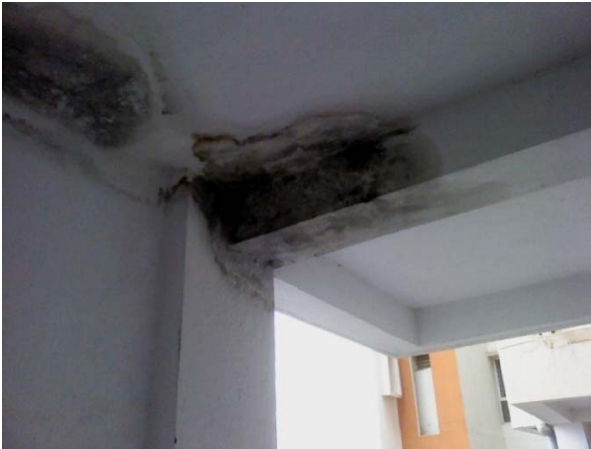
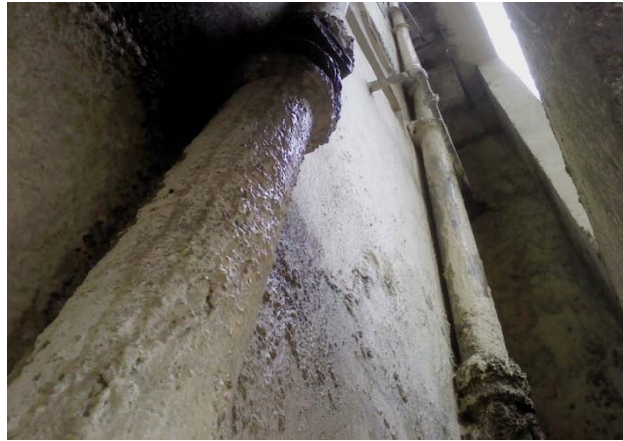
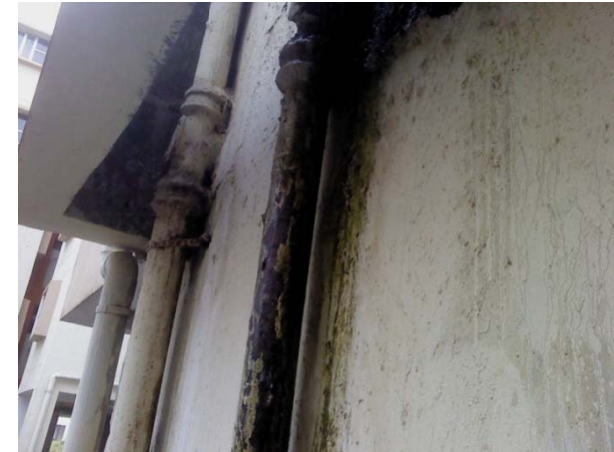
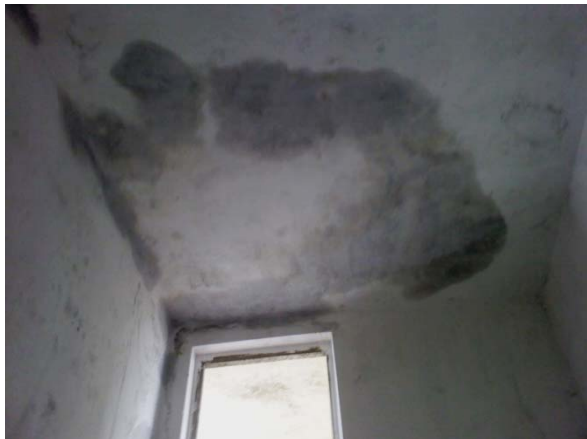
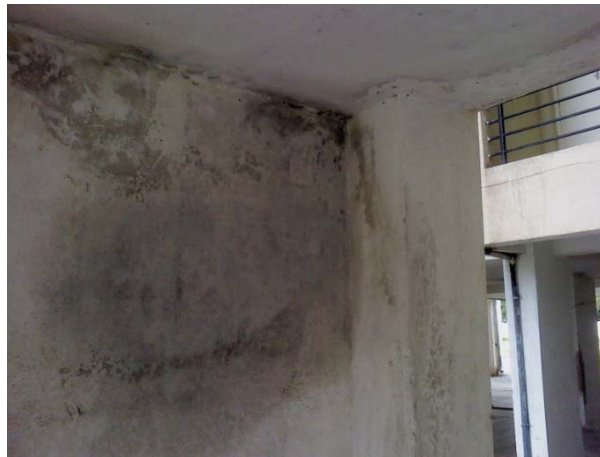
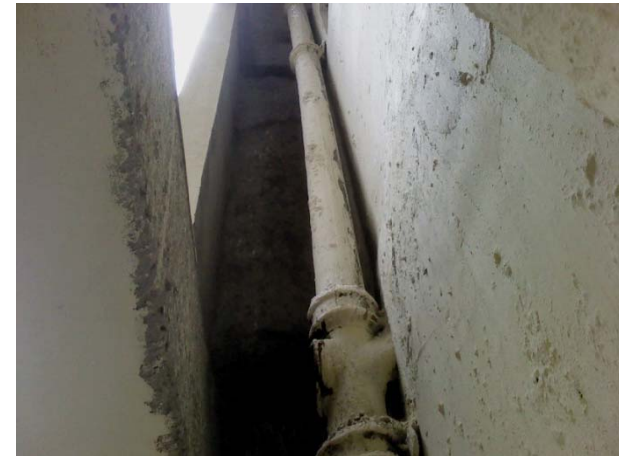
## Leakages: Stilt, Staircase room and Water Tank

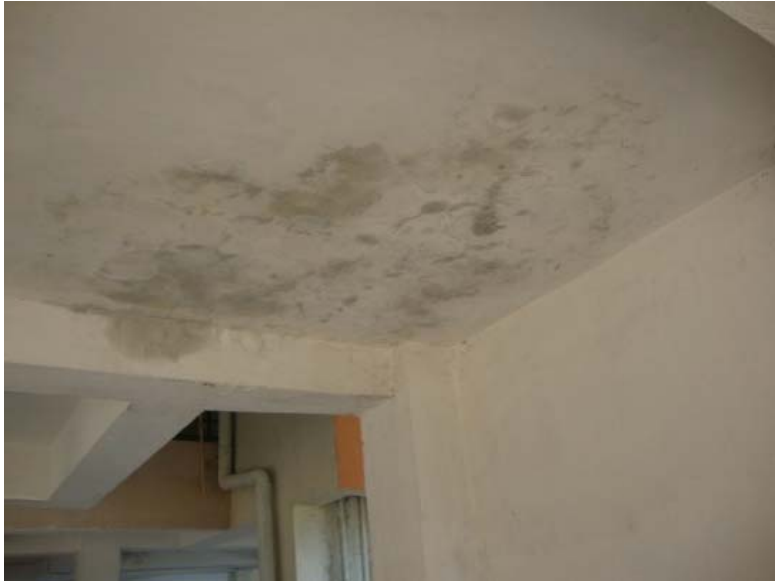
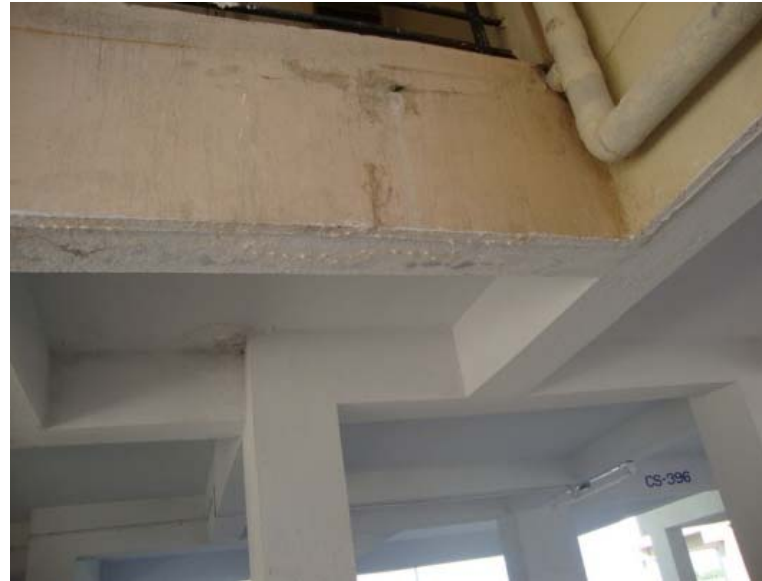
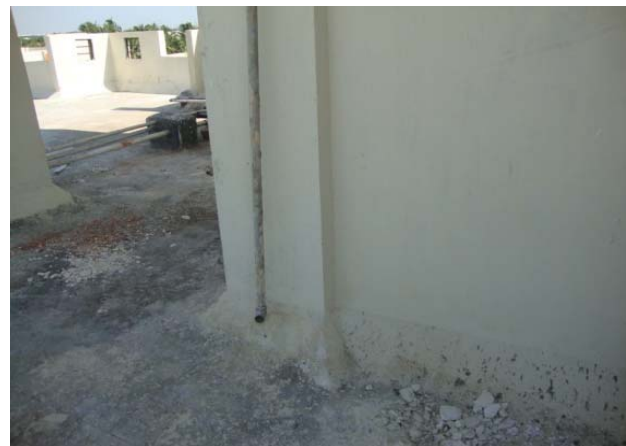
## Leakages: Stilt, Staircase room and Water Tank

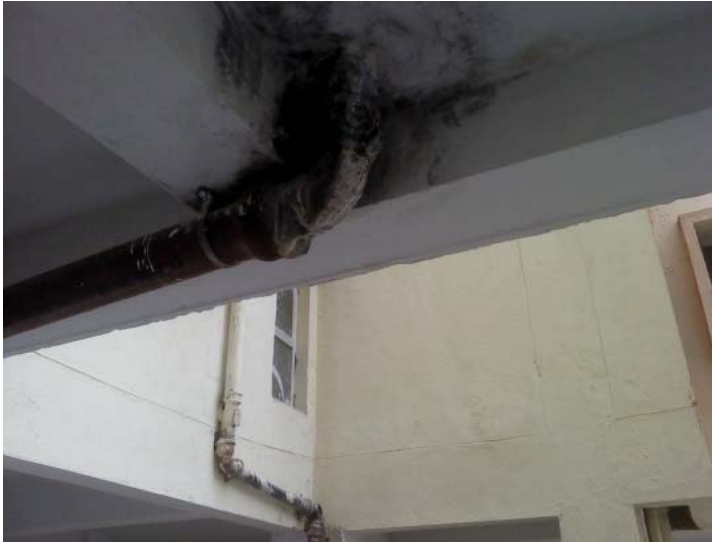
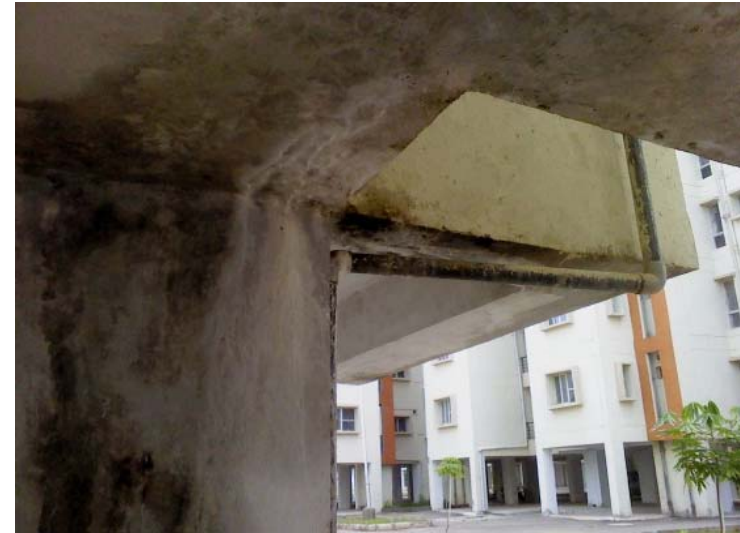
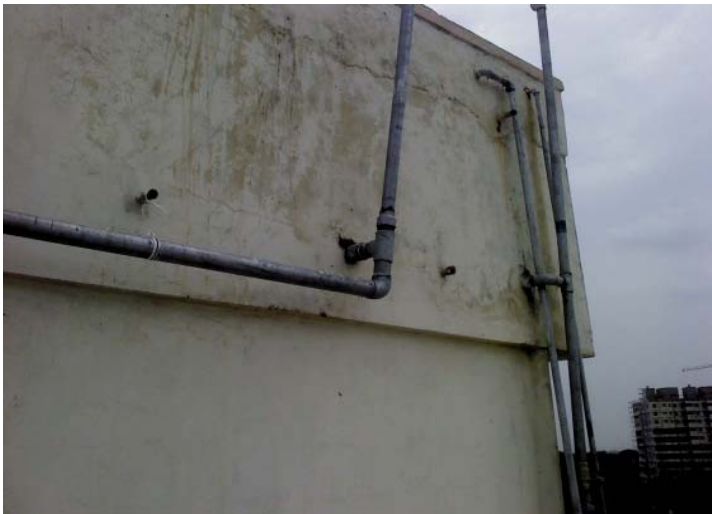
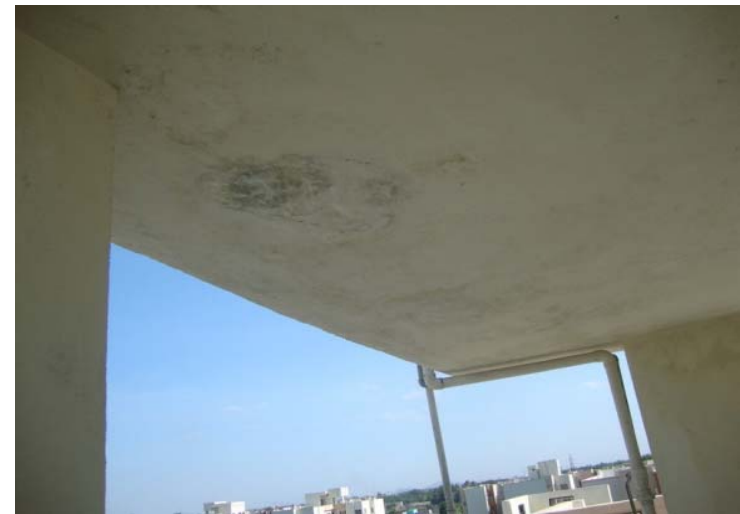
## Leakages: Stilt, Staircase room and Water Tank

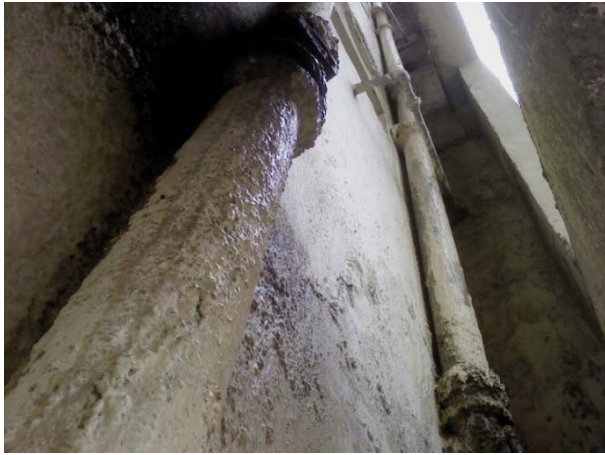
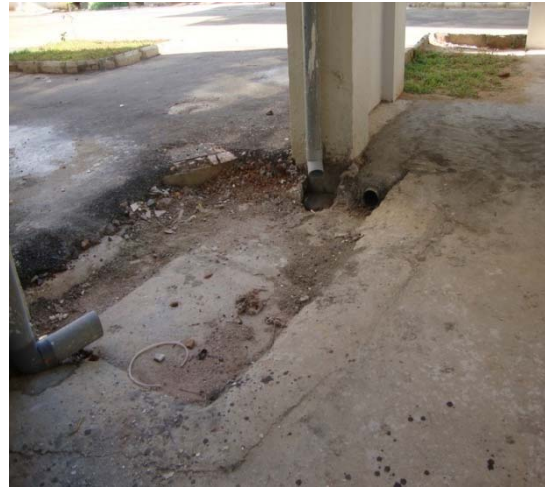
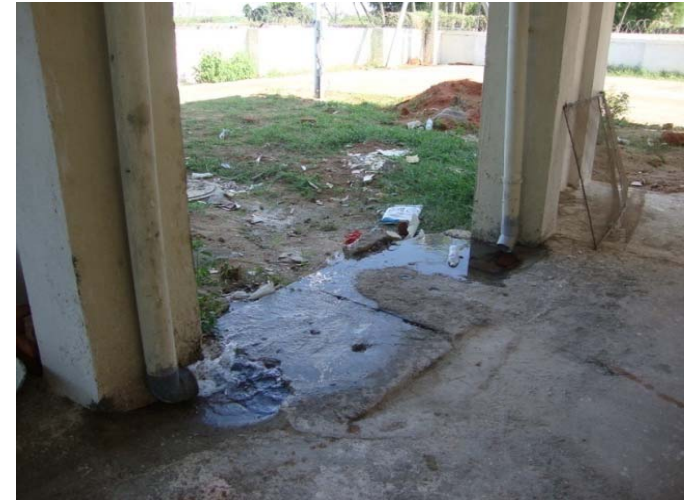
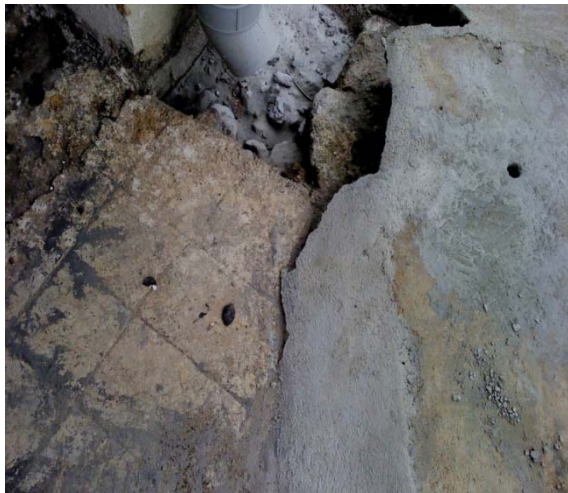
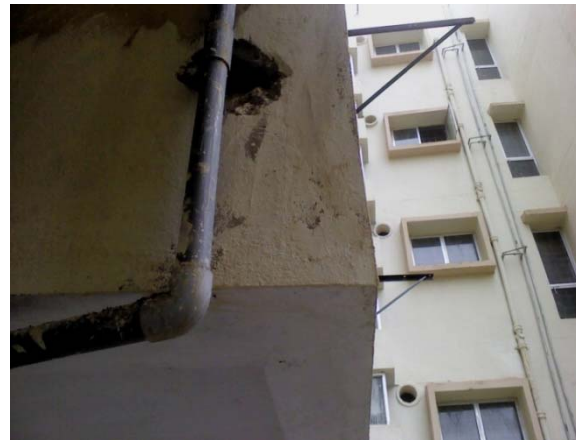
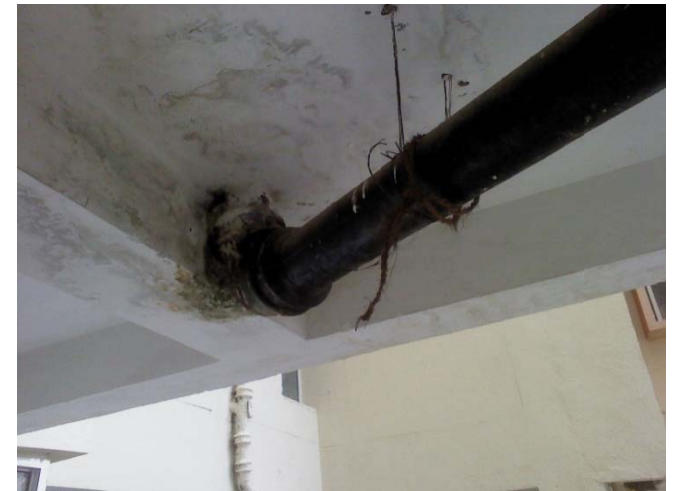
**Drain pipes: Not aligned/placed/anchored and Poor alignment/incorrect joining of SCI pipes**

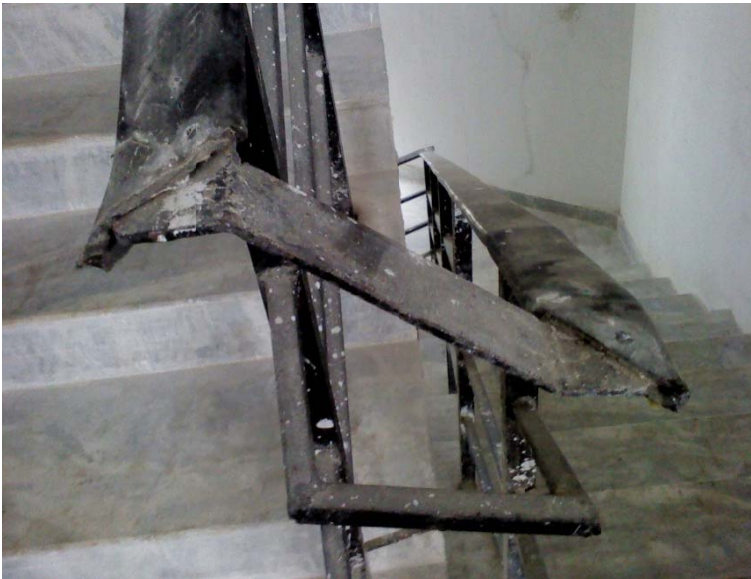
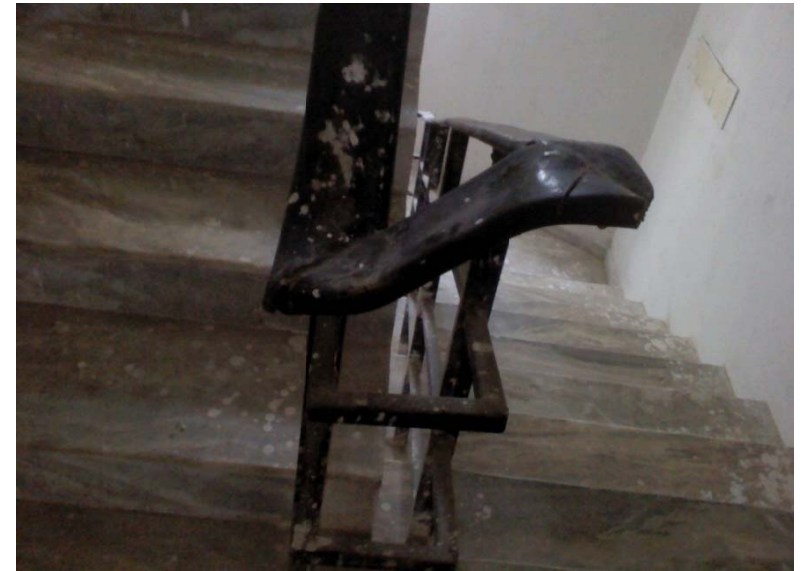
1. Non-uniform riser in some flights.
2. Communication and power cable boxes not covered in some locations.
3. Handrails not been finished smoothly in most places.
4. Dampness in a few staircase head rooms, due to leakage in overhead water tanks.
5. Plaster Patches remains to be completed in a few blocks.

**Staircase: Hand rails not covered / finished, Non Uniform riser and marble broken**

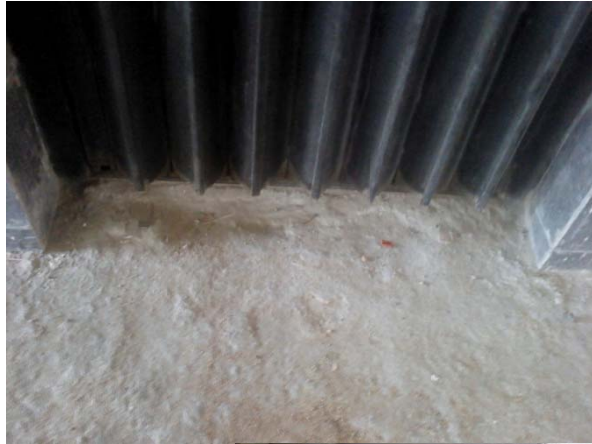
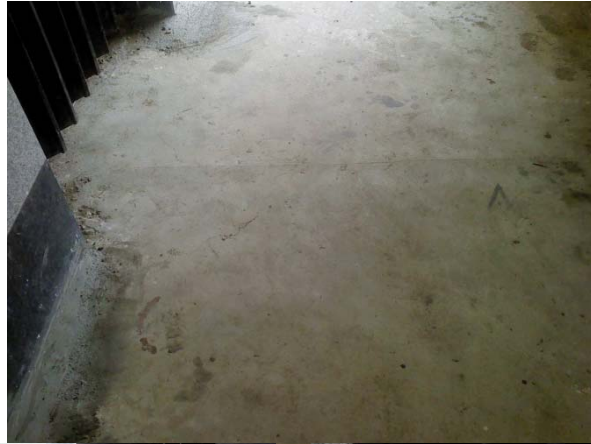
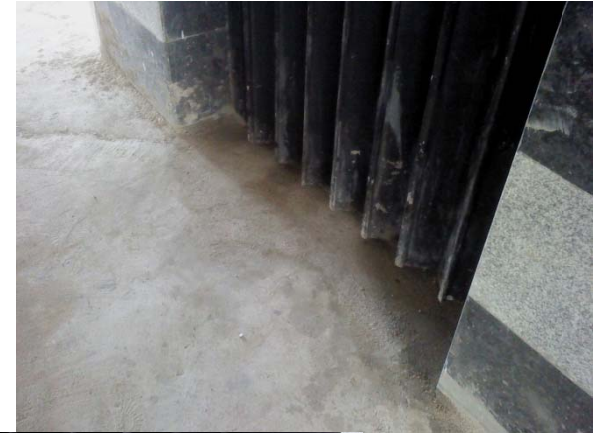
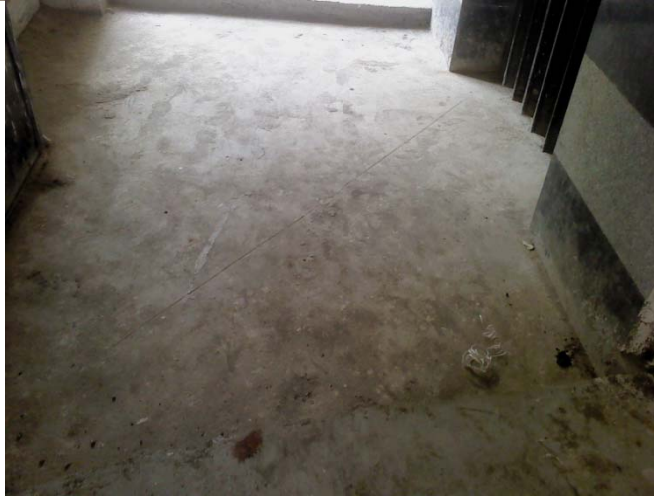
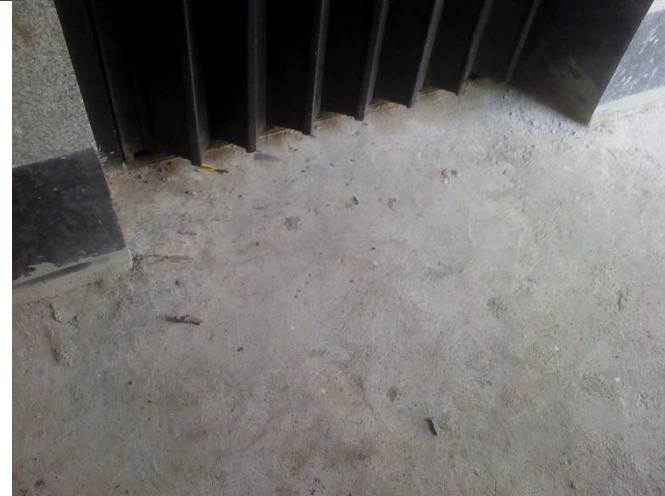
**Lift: Door entry not finished and Inadequate level difference**

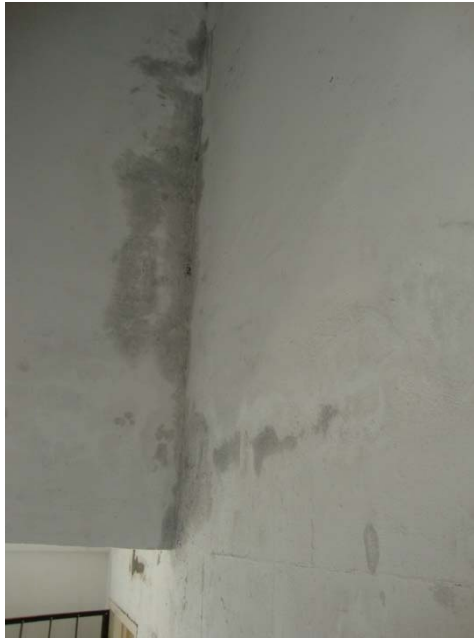
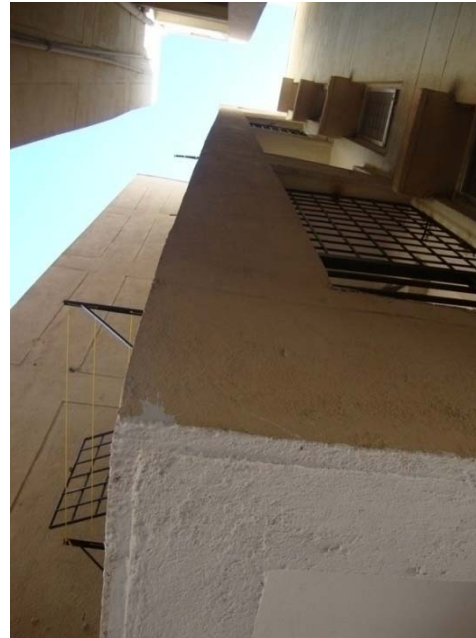
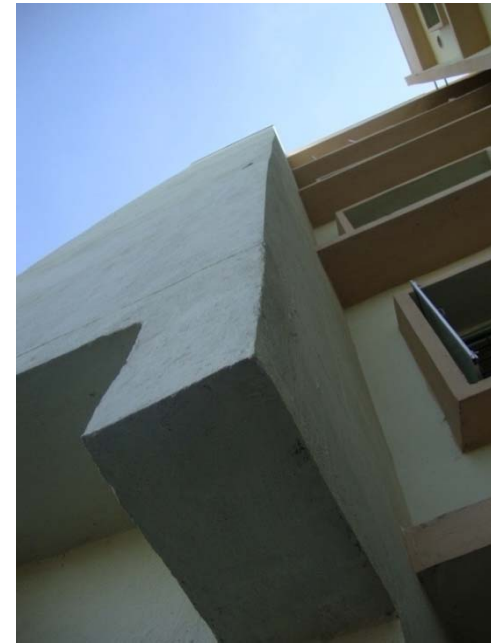
**External Wall: Dampness, Poor Alignment and wall surfaces not finished**

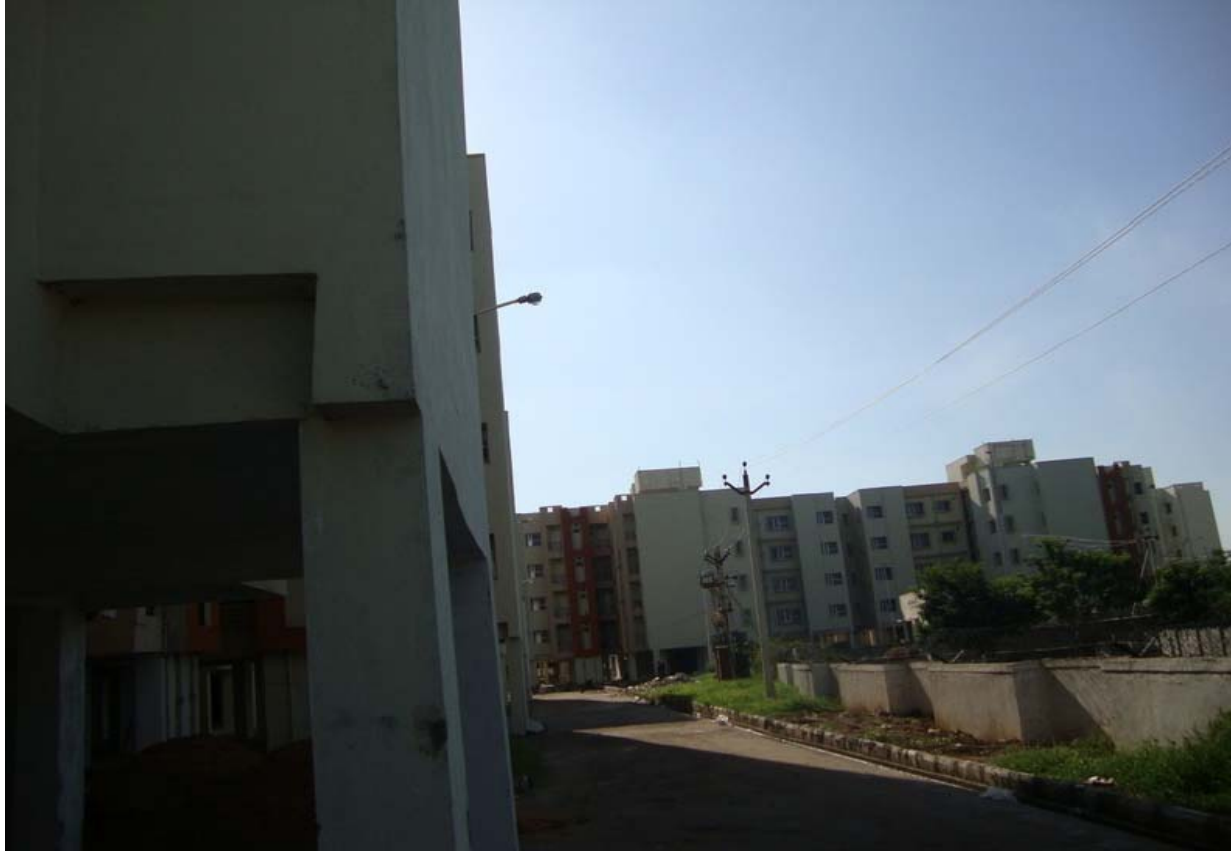
- Development works
    - a. Roads: non-provision of camber, undulation in the paved surface and wearing of the seal coat.
    - b. Storm water drainage: inadequate slope and improper termination of rain water pipes and inadequate open section of drains.

**Road with Storm water Drain: No Camber provided and Open drain with inadequate section**
