30.06.2018

PHOTOGRAPHS OF C1 BLOCK AS ON 30.06.2018

BIRD EYE VIEW PHOTOGRAPHS OF CHENNAI PHASE-III PROJECT

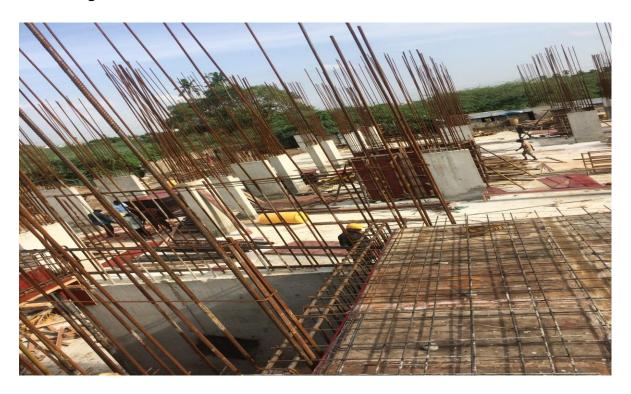
In Block C1 First floor level slab .First half concrete completed, Second half Shuttering Process.

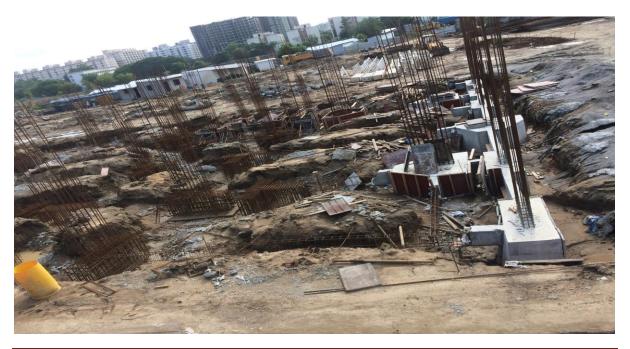
In Block C2 Excavation work, Shuttering for Short Column and for Pile cap Works on progress.

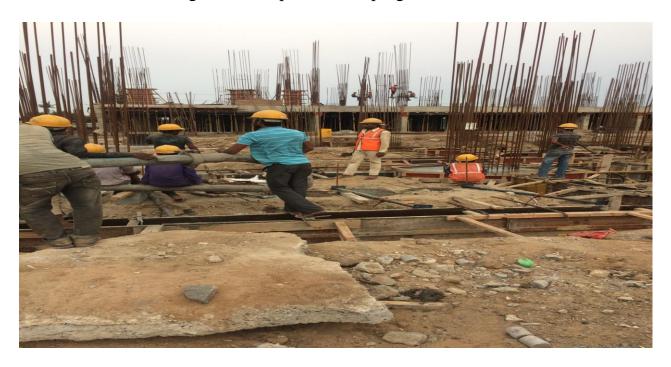
In Block C2 Concreting for Pile cap Works on progress.

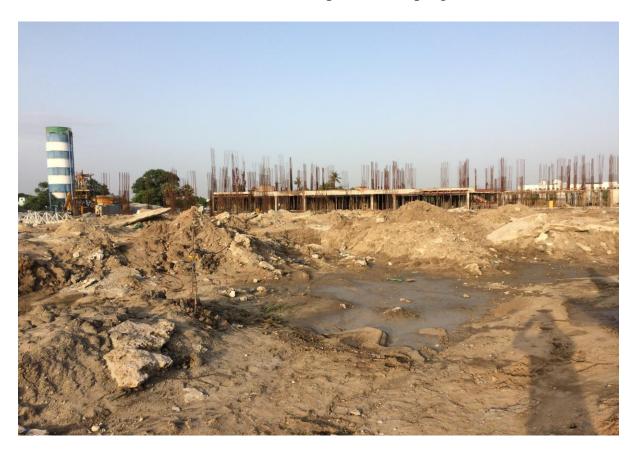
In Block C3 Excavation work for Pile Cap works on progress.

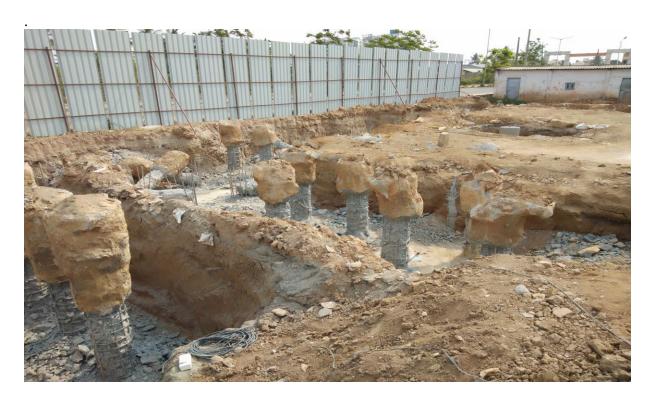
In Community Centre excavation for pile cap works & pile chipping up to cut off level on progress.

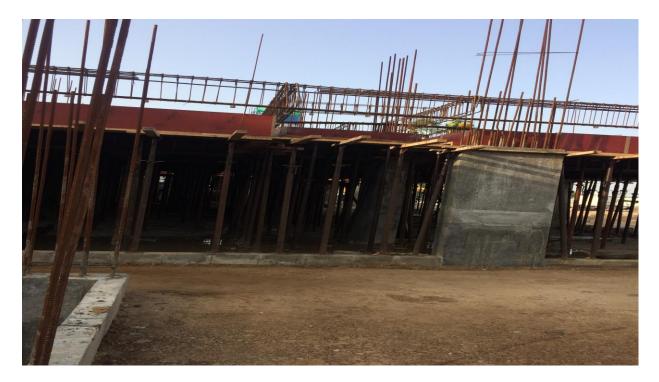
In Block B1 shuttering work for First floor level slab is in progress.

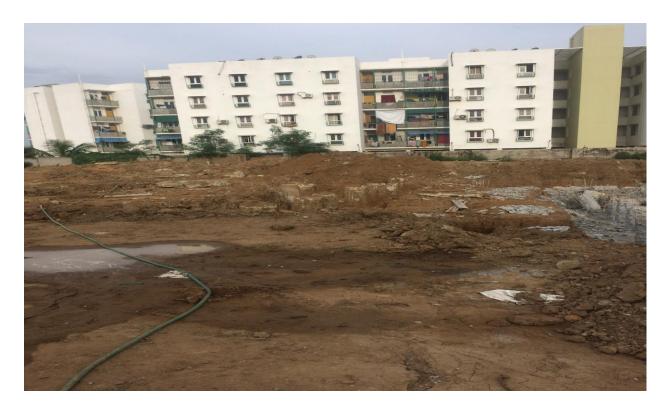
In Block B2 Excavation Work for Pile Cap Works on process.

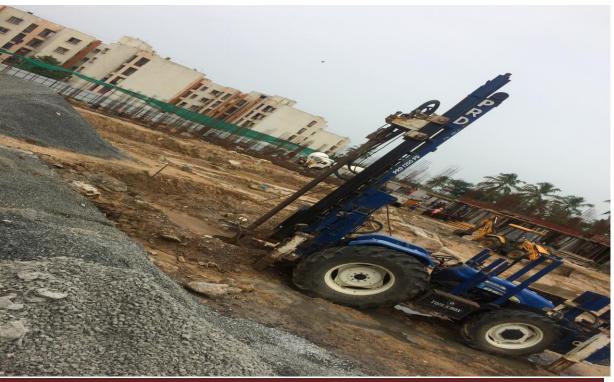
In Block D1 Pilling Work in Process

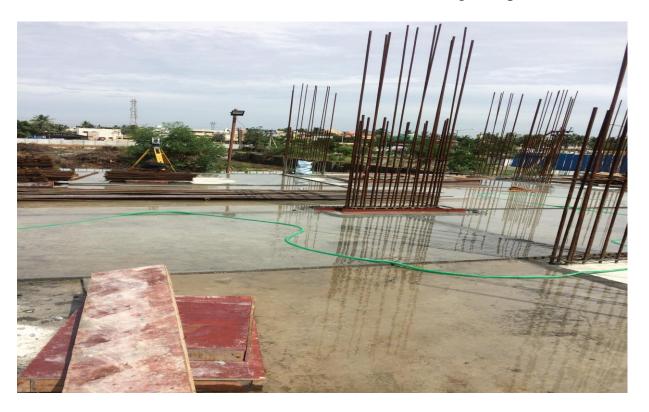
In Block D2 First Floor Level - First half Concrete Casting Completed.

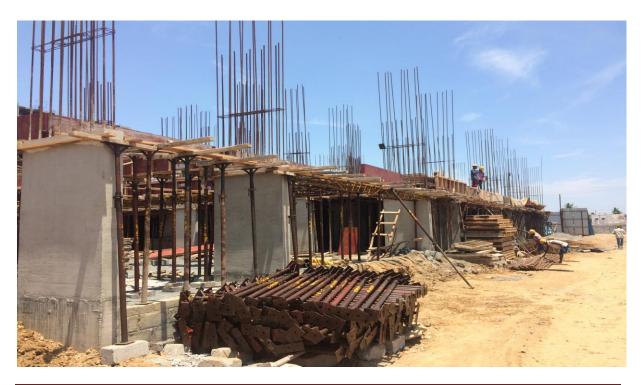
In Block D2 -Shuttering & Bar bending Works on Progress for Second half of First Floor Level Slab

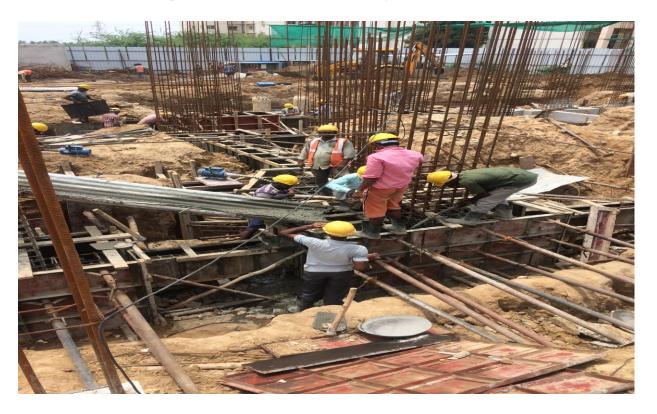
In Block D3 Pile Cap Concrete Works are in Progress.

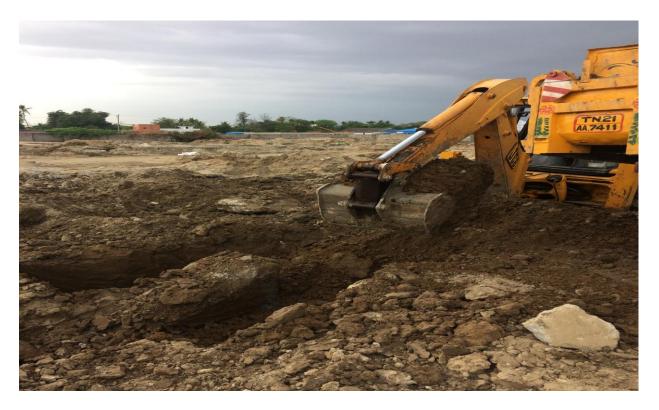
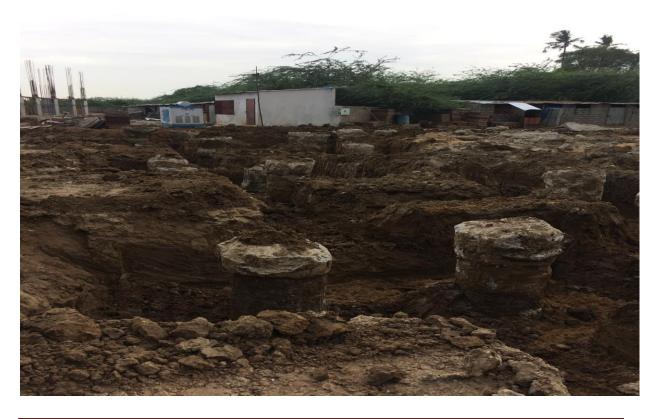
In Block A1 & A2 Excavation works for Pile Cap Works are in progress.

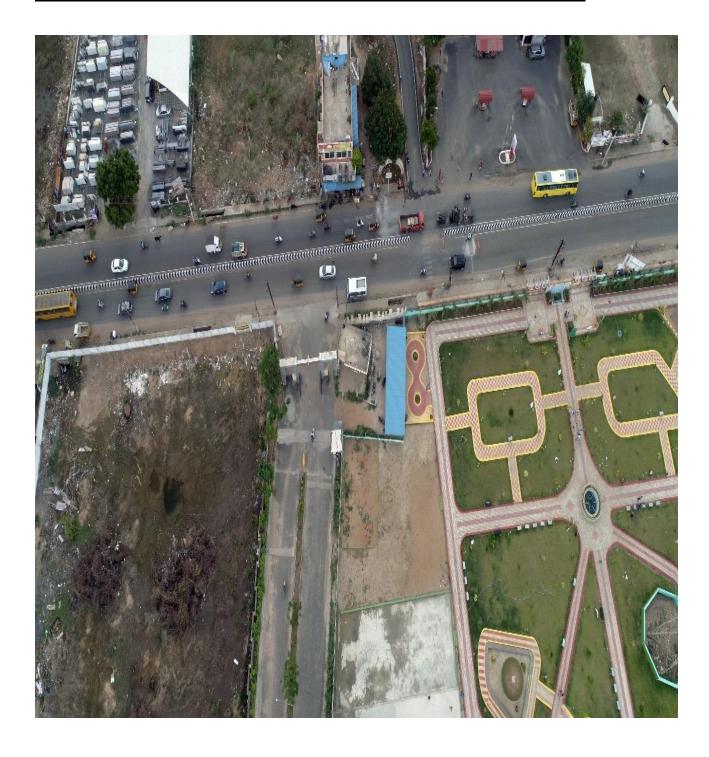
VIEW OF ENTRANCE FROM MAIN ROAD SHOWING MAIN GATE, COMMUNITY CENTRE & PARK DEVELOPED BY AVADI MUNICIPALITY ON OUR OSR LAND

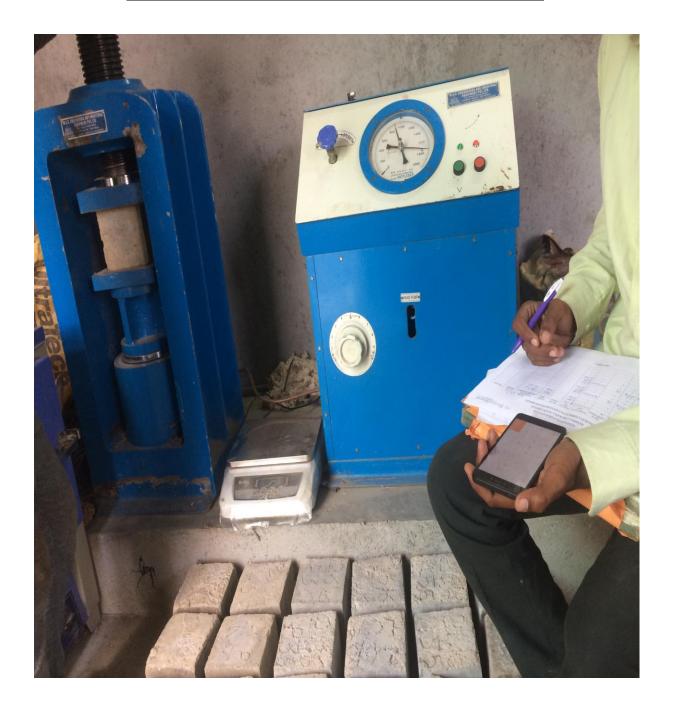
Concrete Cube Compressive Strength Testing

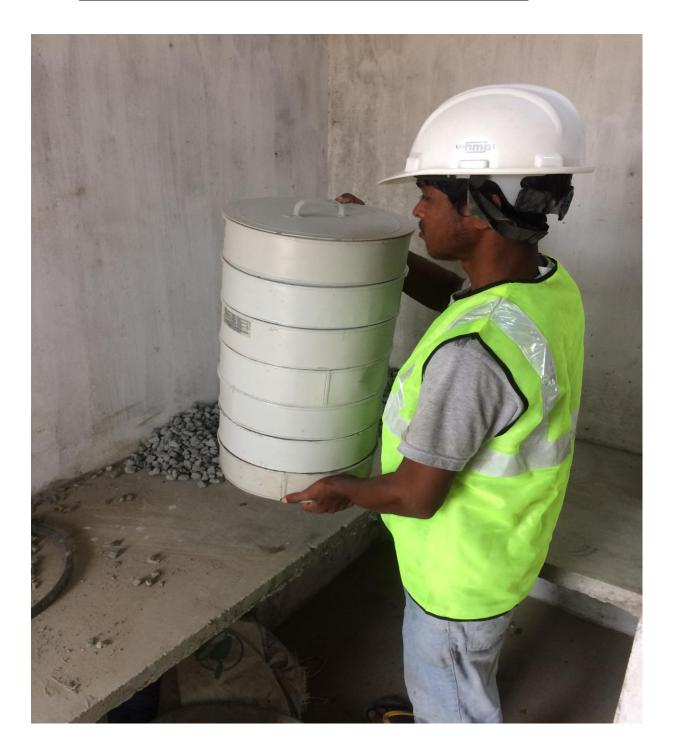
20mm & 12mm Aggregate Sieve Analysis Testing

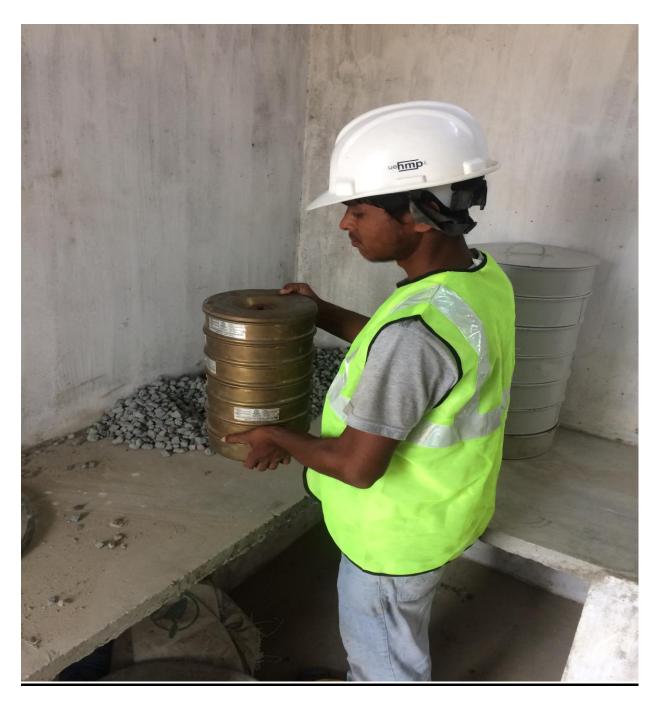
Fine Aggregate Sieve Analysis Testing
