**CGEWHO – CHENNAI PHASE-III
PROJECT**

MONTHLY PROGRESS REPORT

STATUS AS ON : 31.10.2023

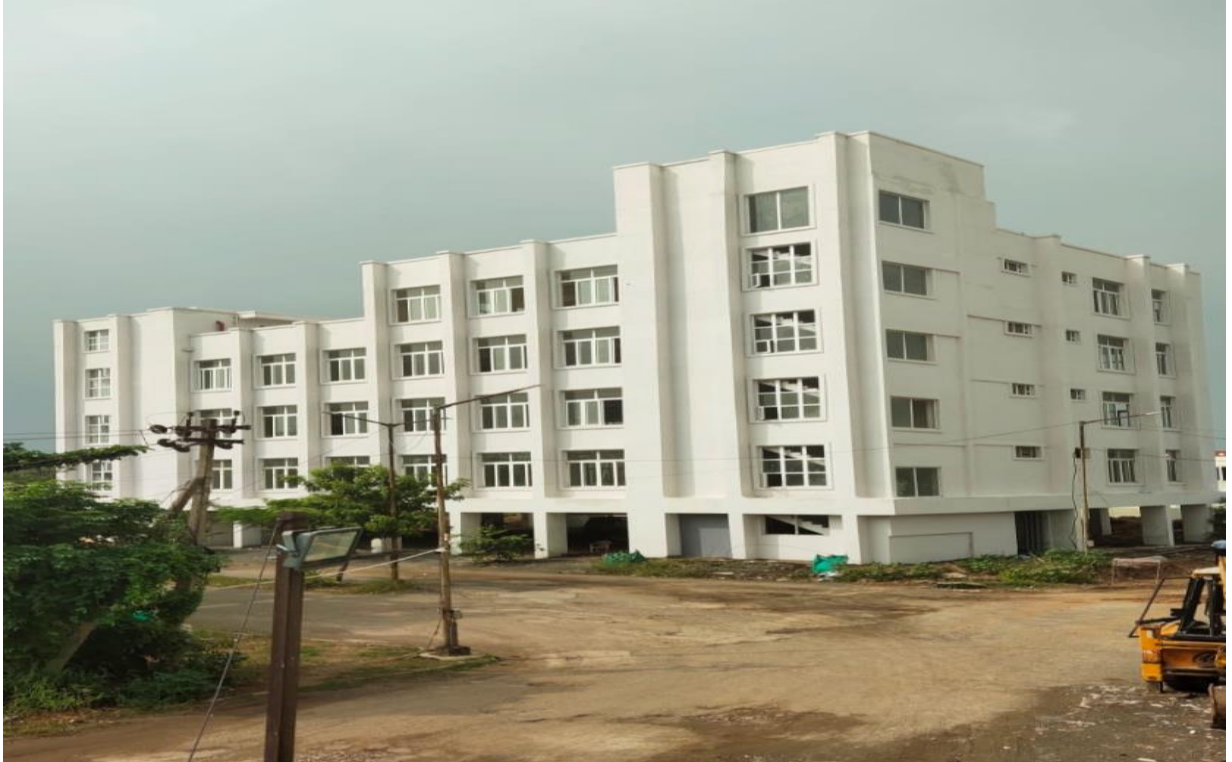
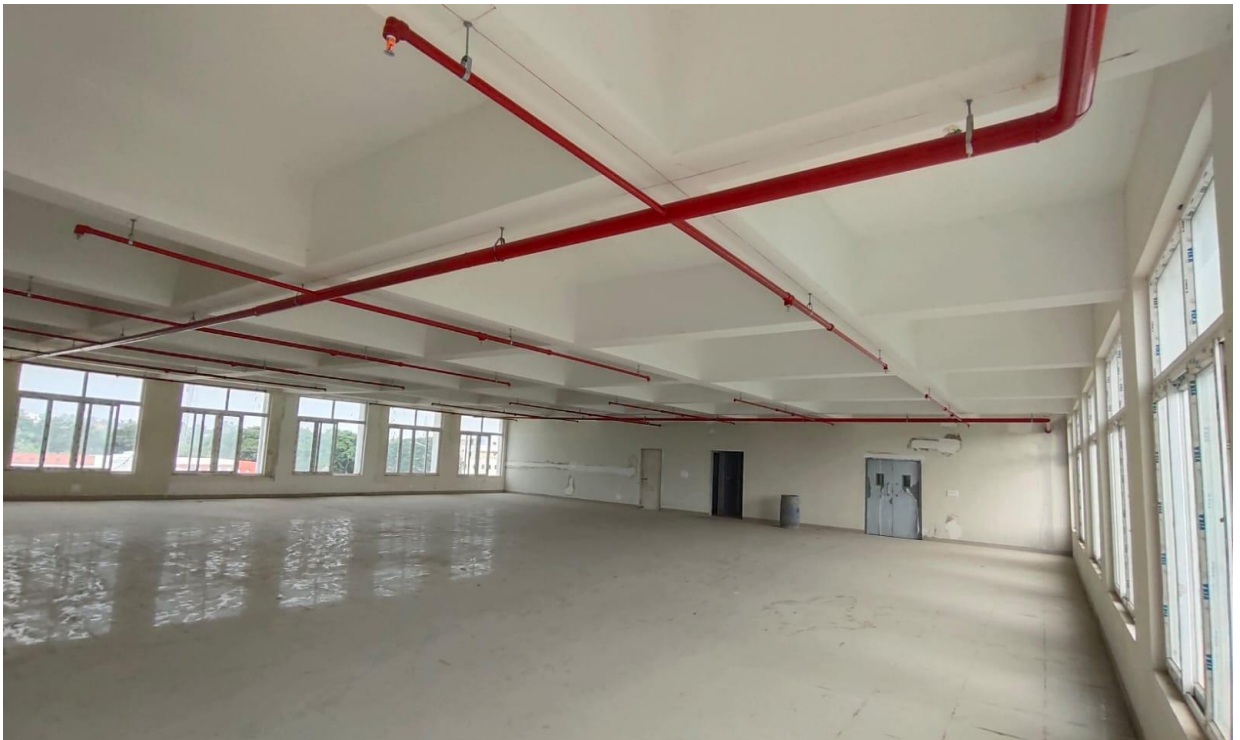
Community Hall: Lift Erection works final corrections on progress. Firefighting works- Fixing of pipelines for sprinkler arrangements on progress.

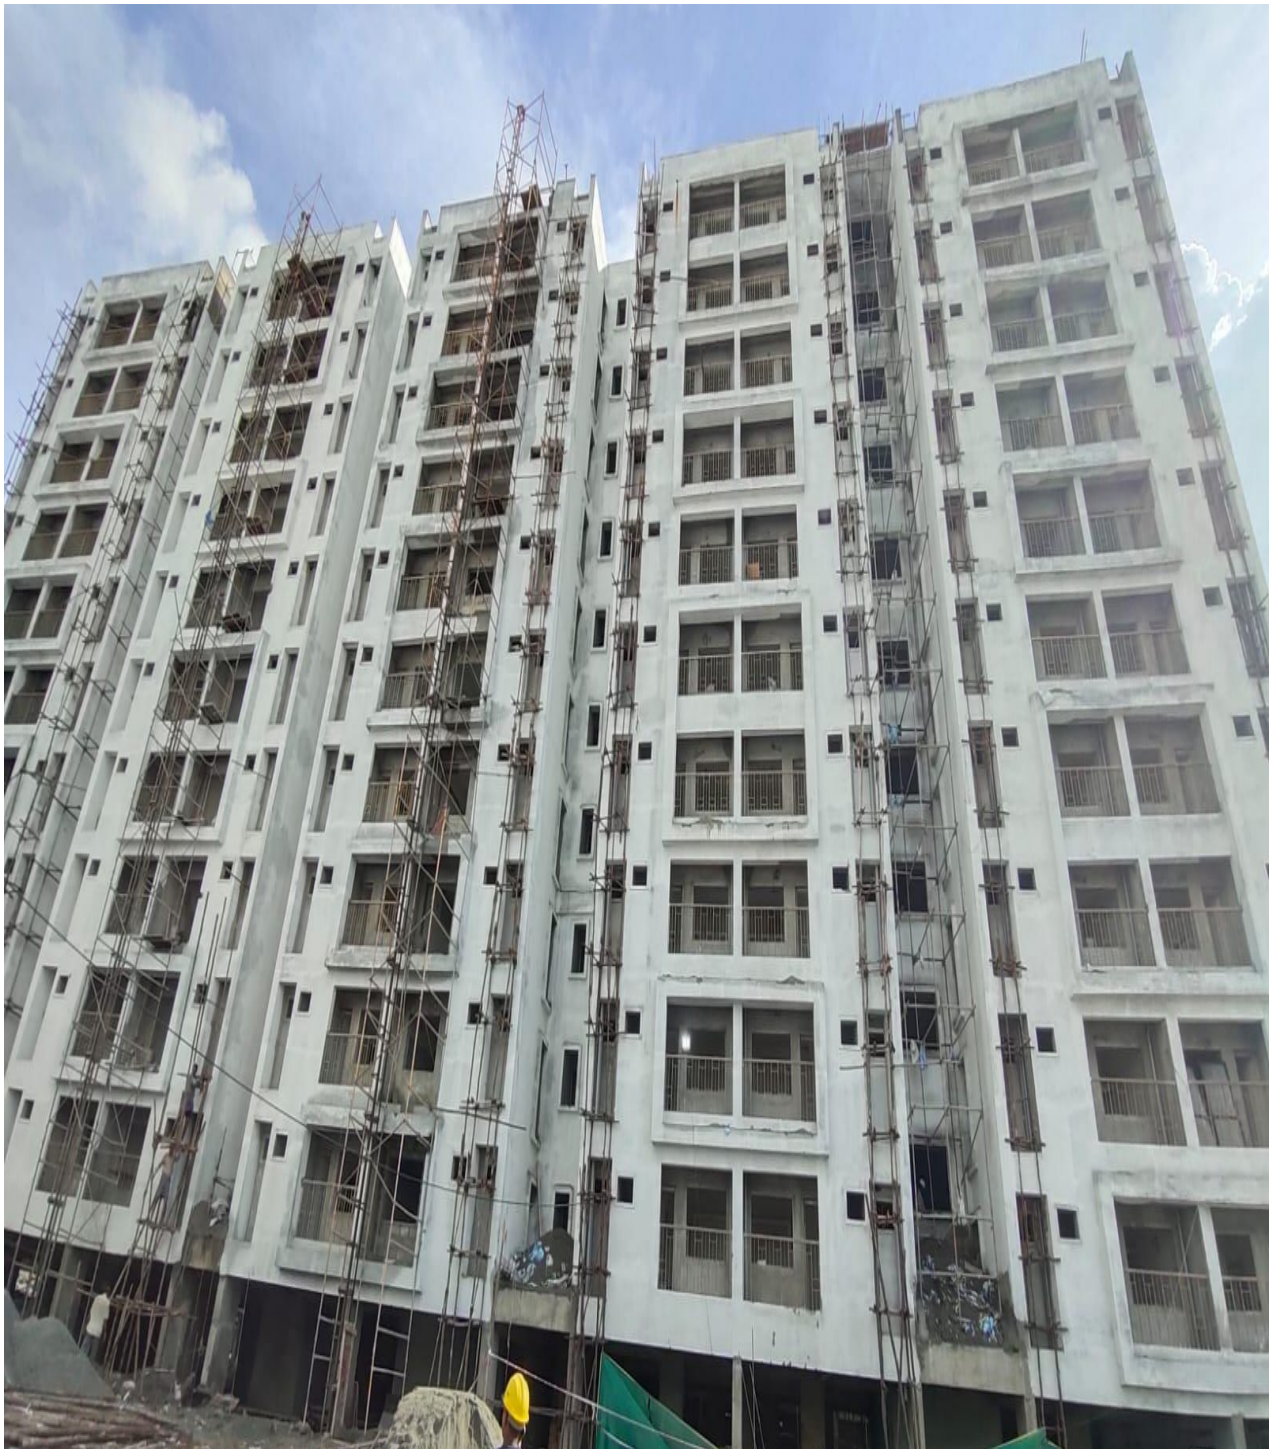
Block A1: External plastering works 90% completed. Vertical Plumbing works on progress. Over Head Water Tank RCC completed.

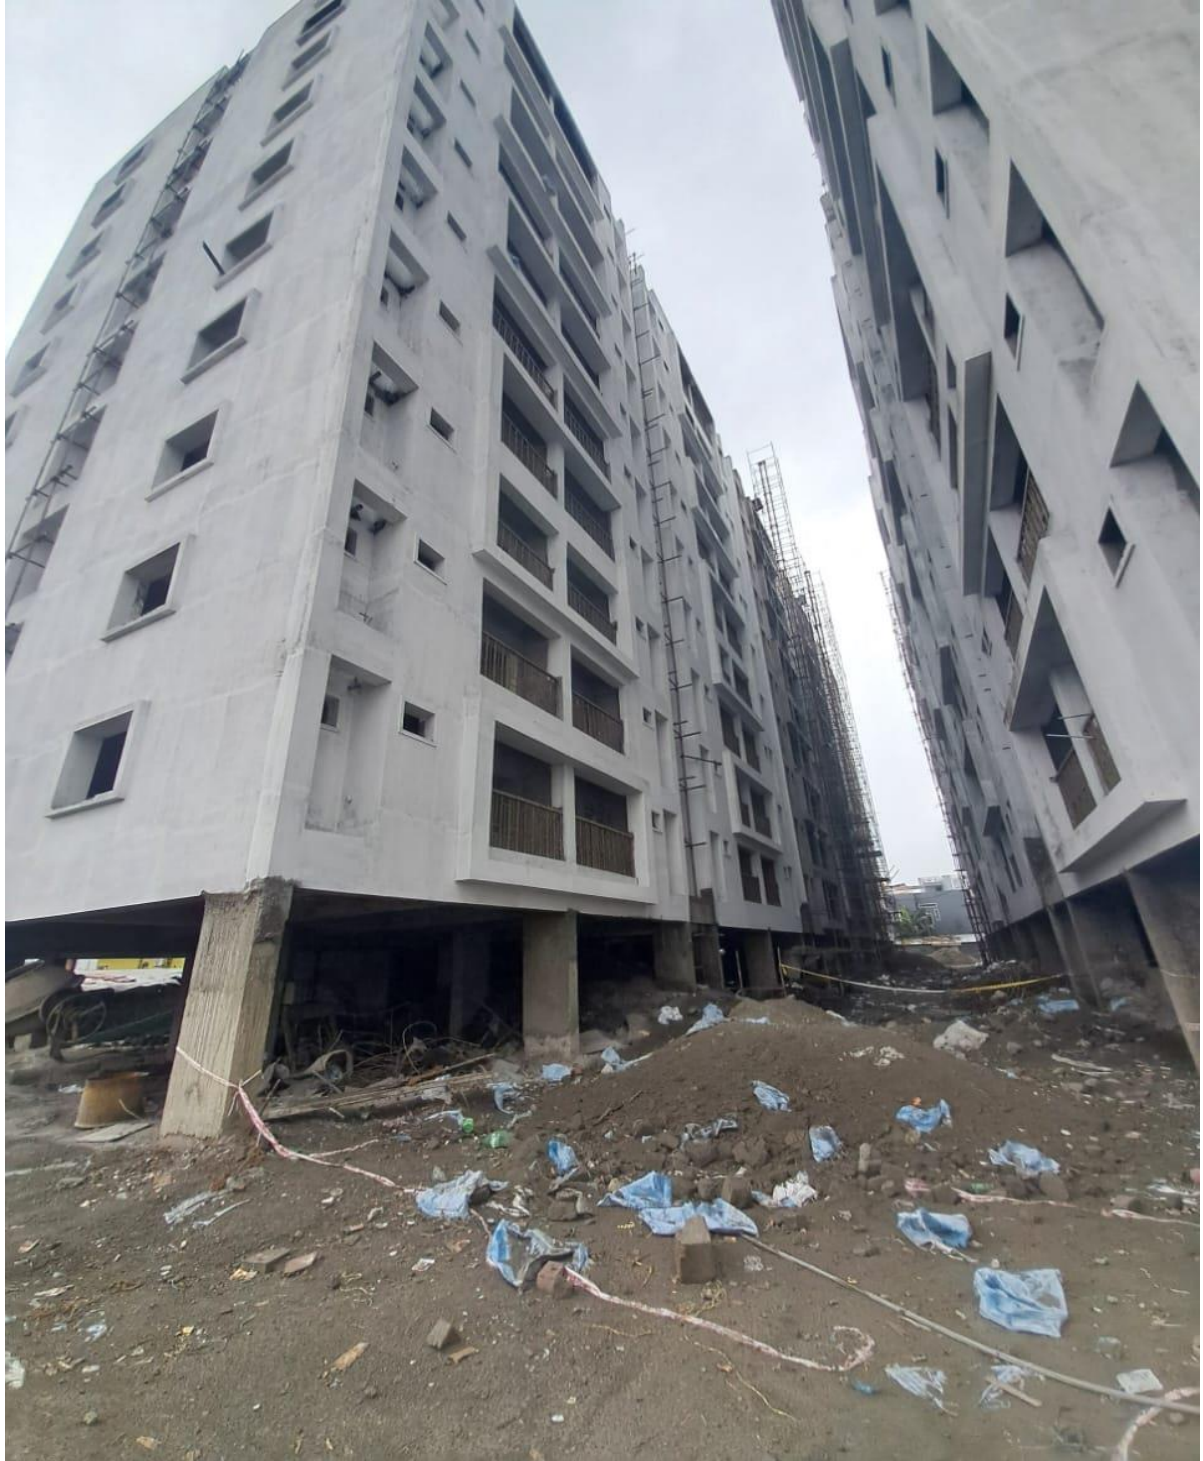
Block A2 : Terrace Floor level slab Concrete casting 100% completed. External Plastering 90% completed. Over Head Water Tank RCC works on progress.

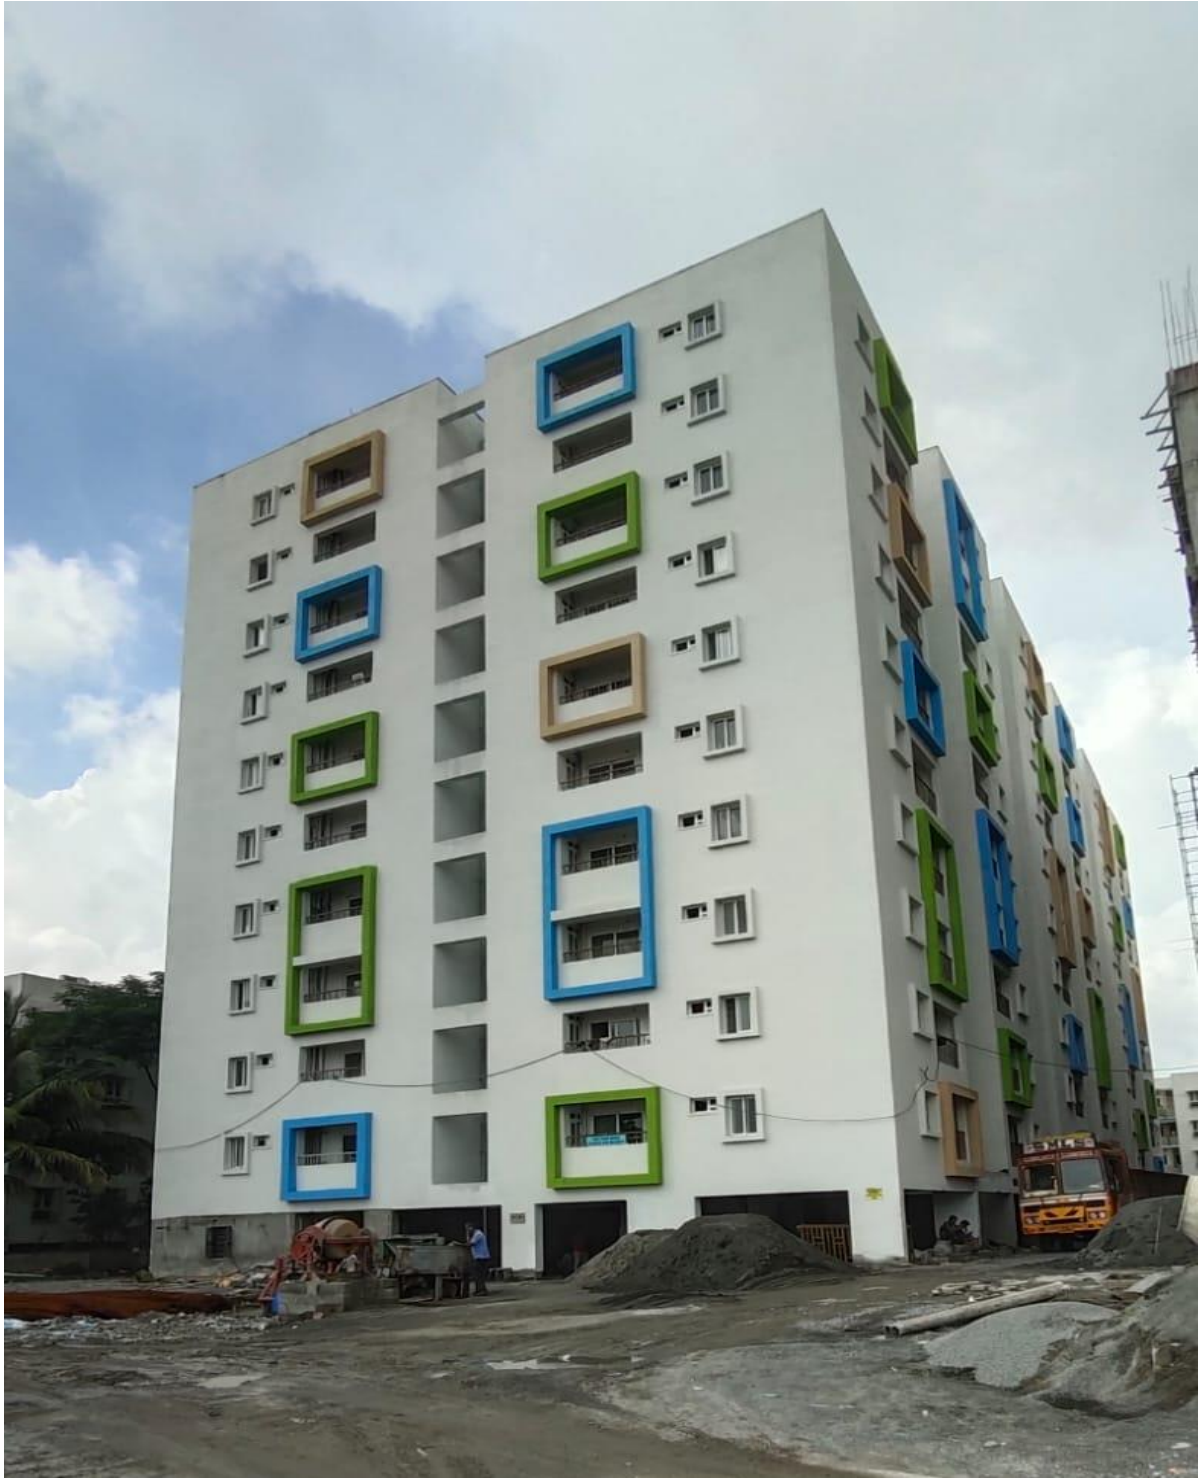
Block B1: Lift Installation works 90% completed. Fixing of UPVC Windows 90% completed. Electrical Wire pulling works on progress.

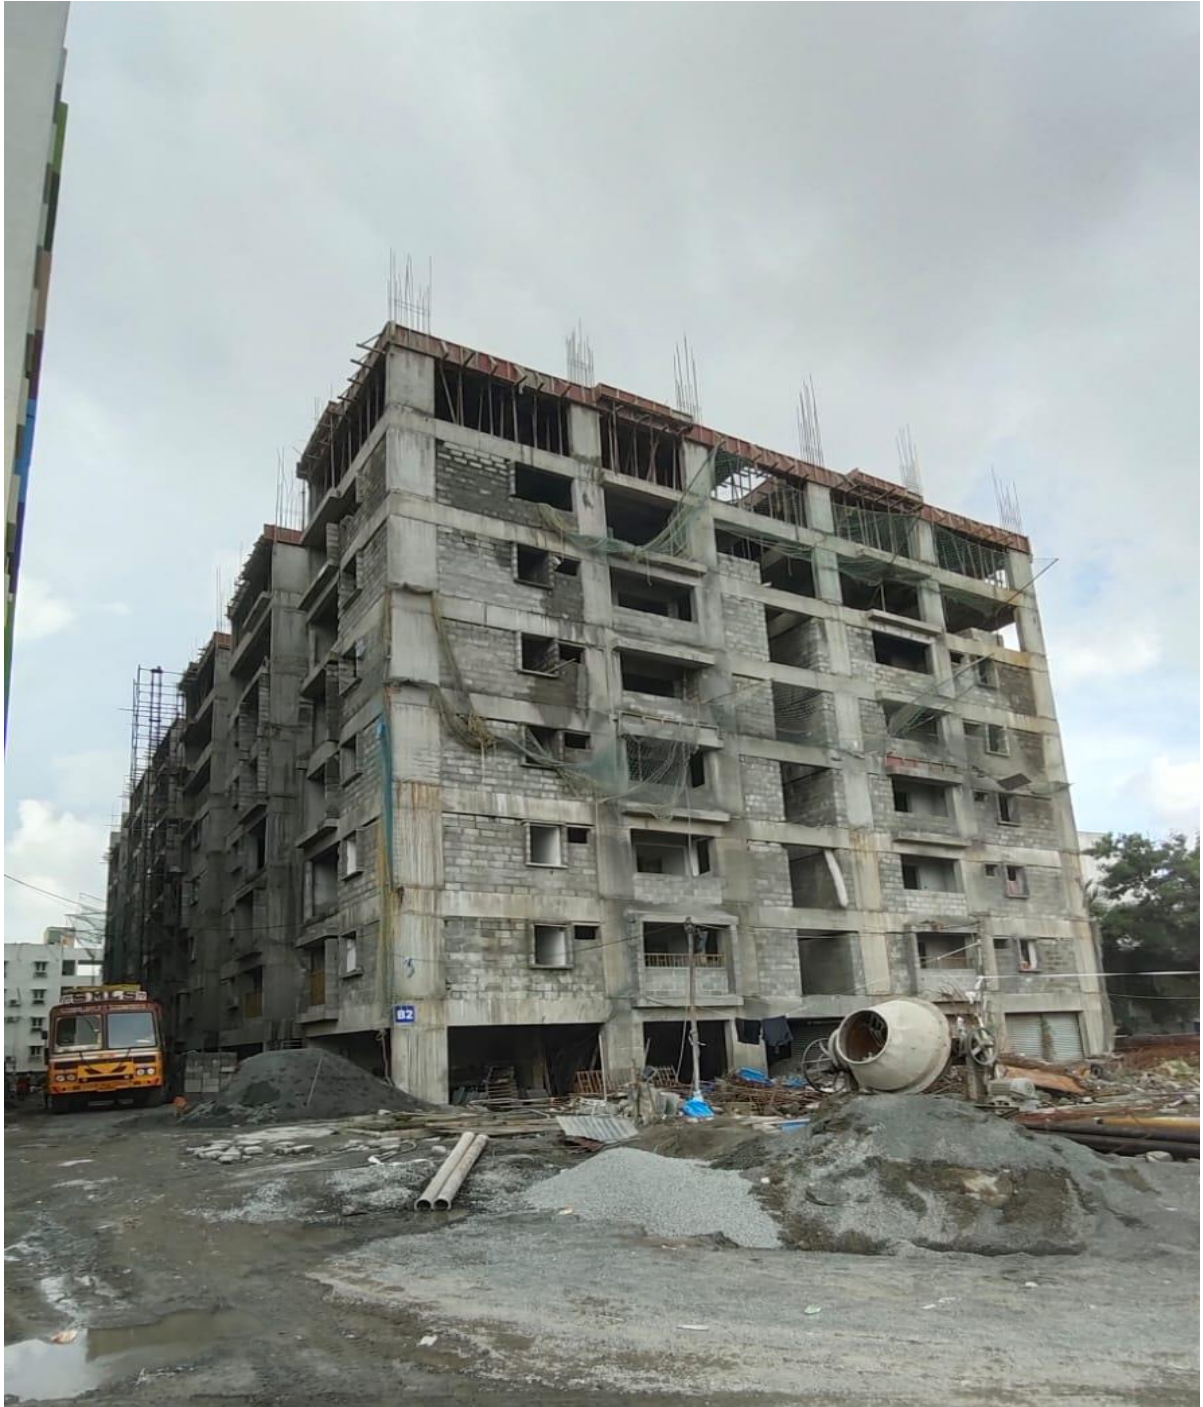
Block B2 : Seventh Floor Level slab concrete casting 100% completed. Shuttering works for 1st half of Eighth floor level slab 90% completed.

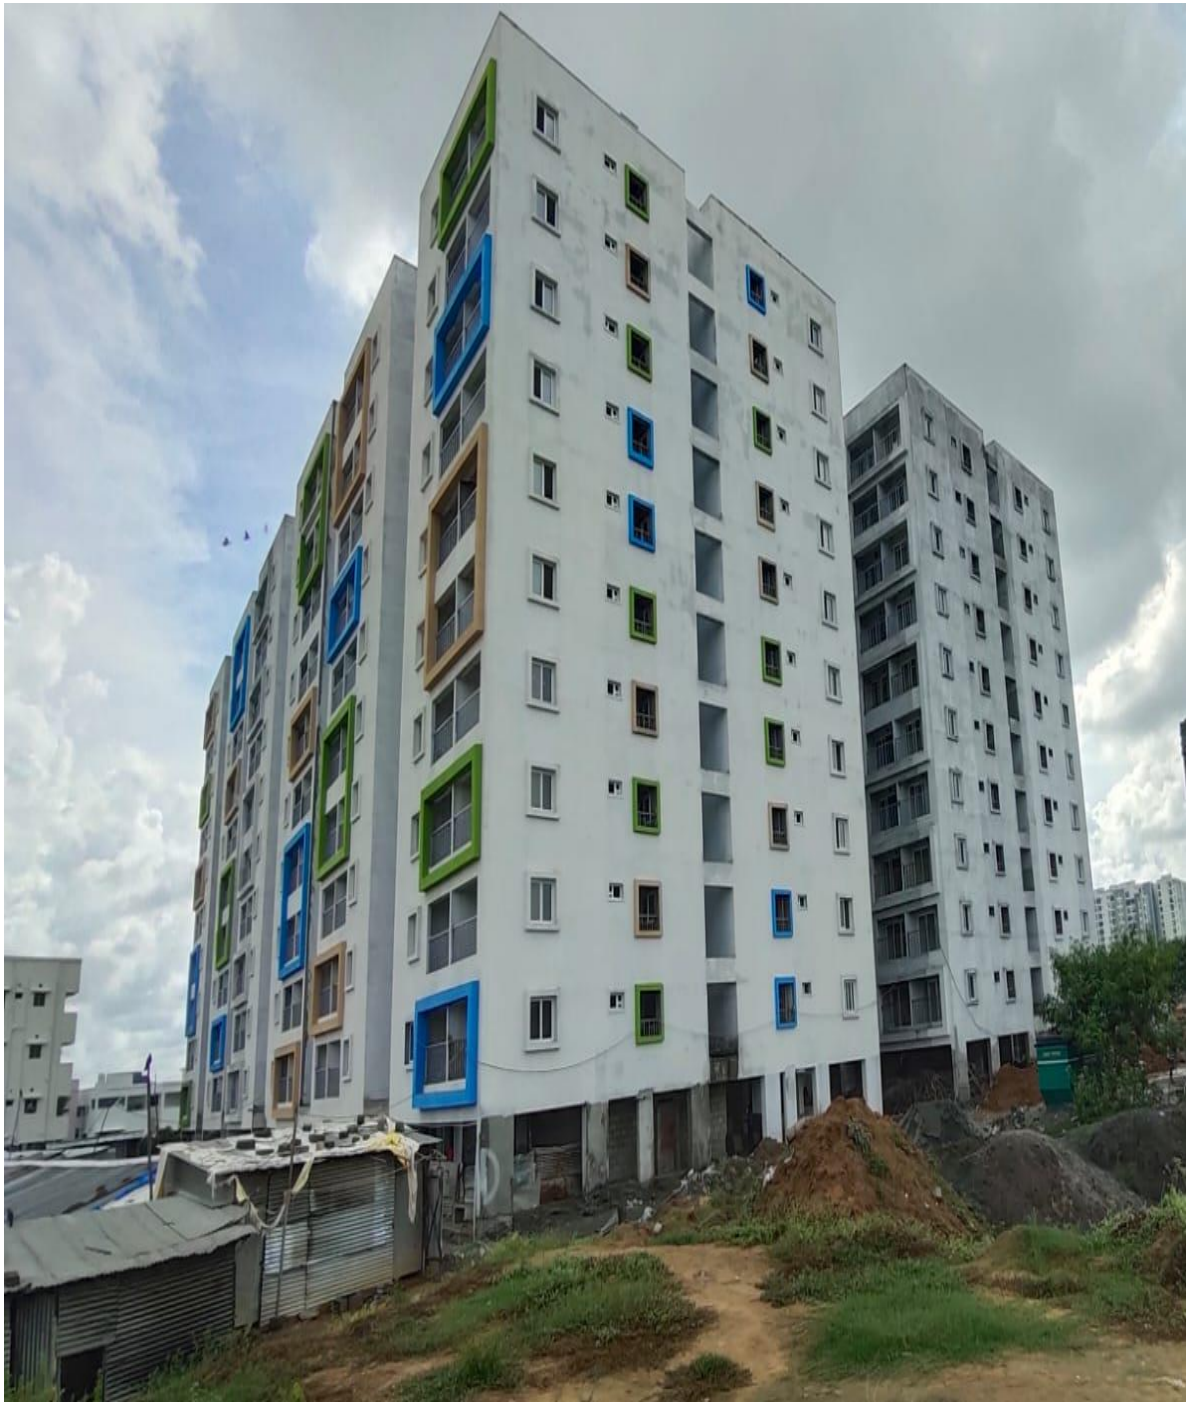
Block C1: Lift Installation works 90% completed. Terrace weathering course work 90% completed.

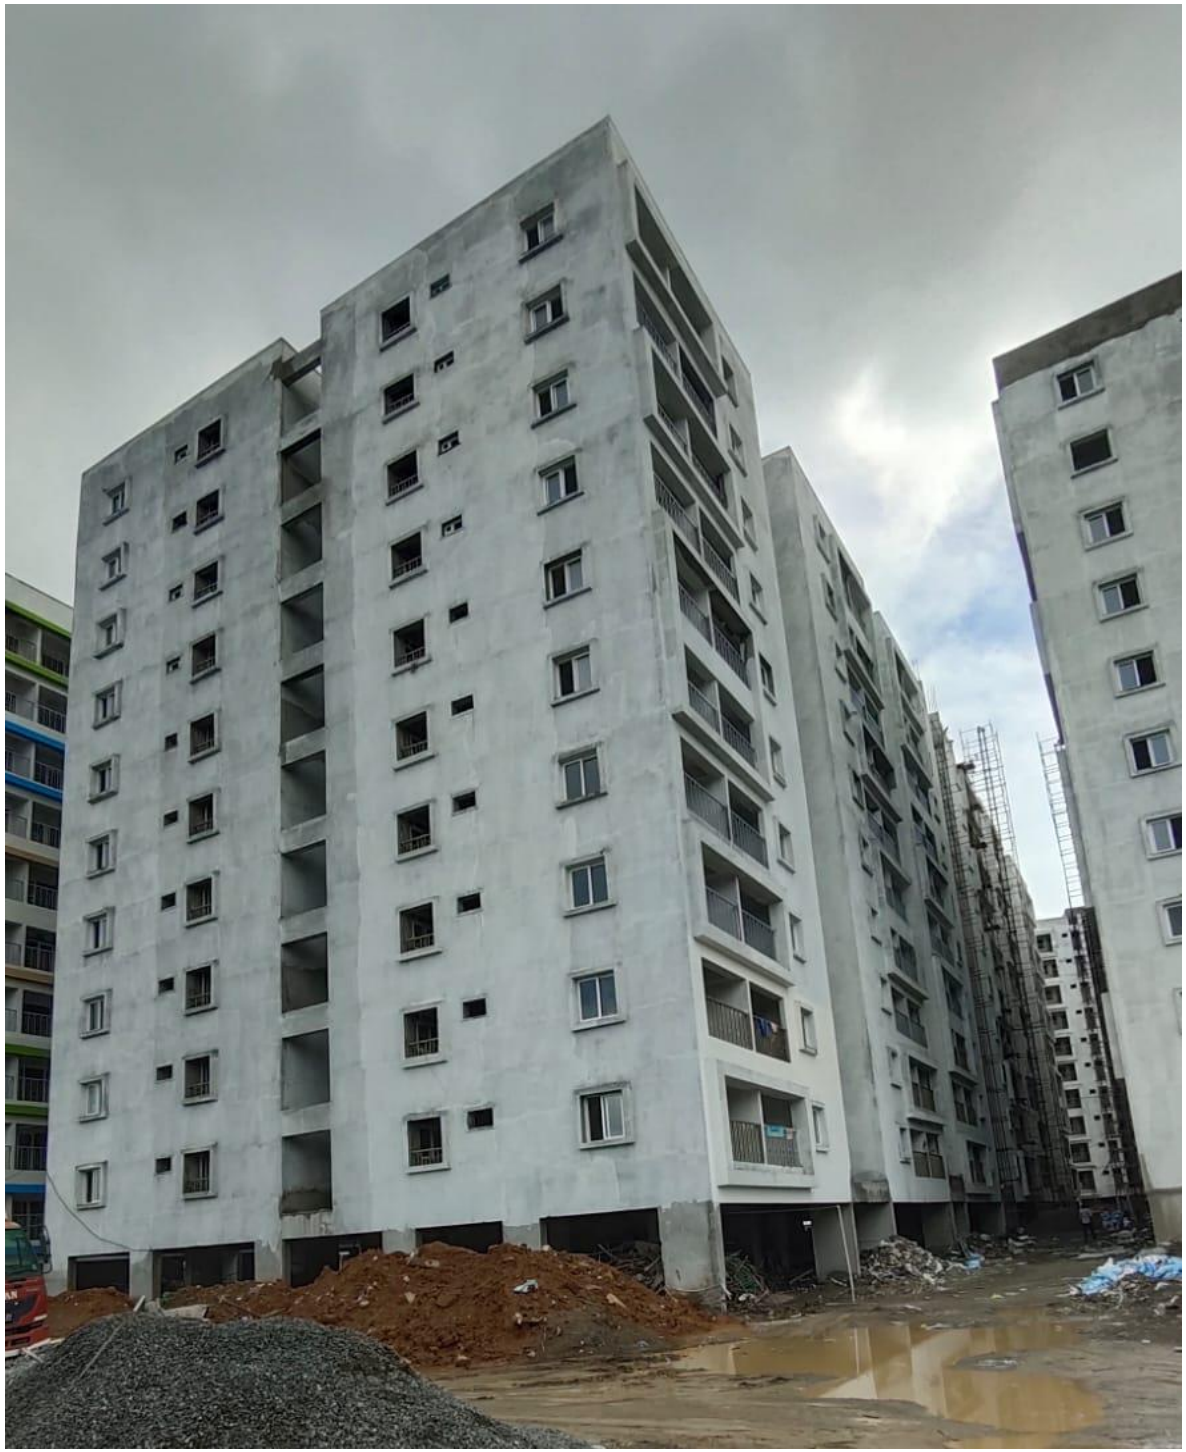
Block C2: Lift Installation works- 2 Lifts out of 4 - 90% completion. Vertical Plumbing Lines completed. Staircase Green marble laying work on progress.

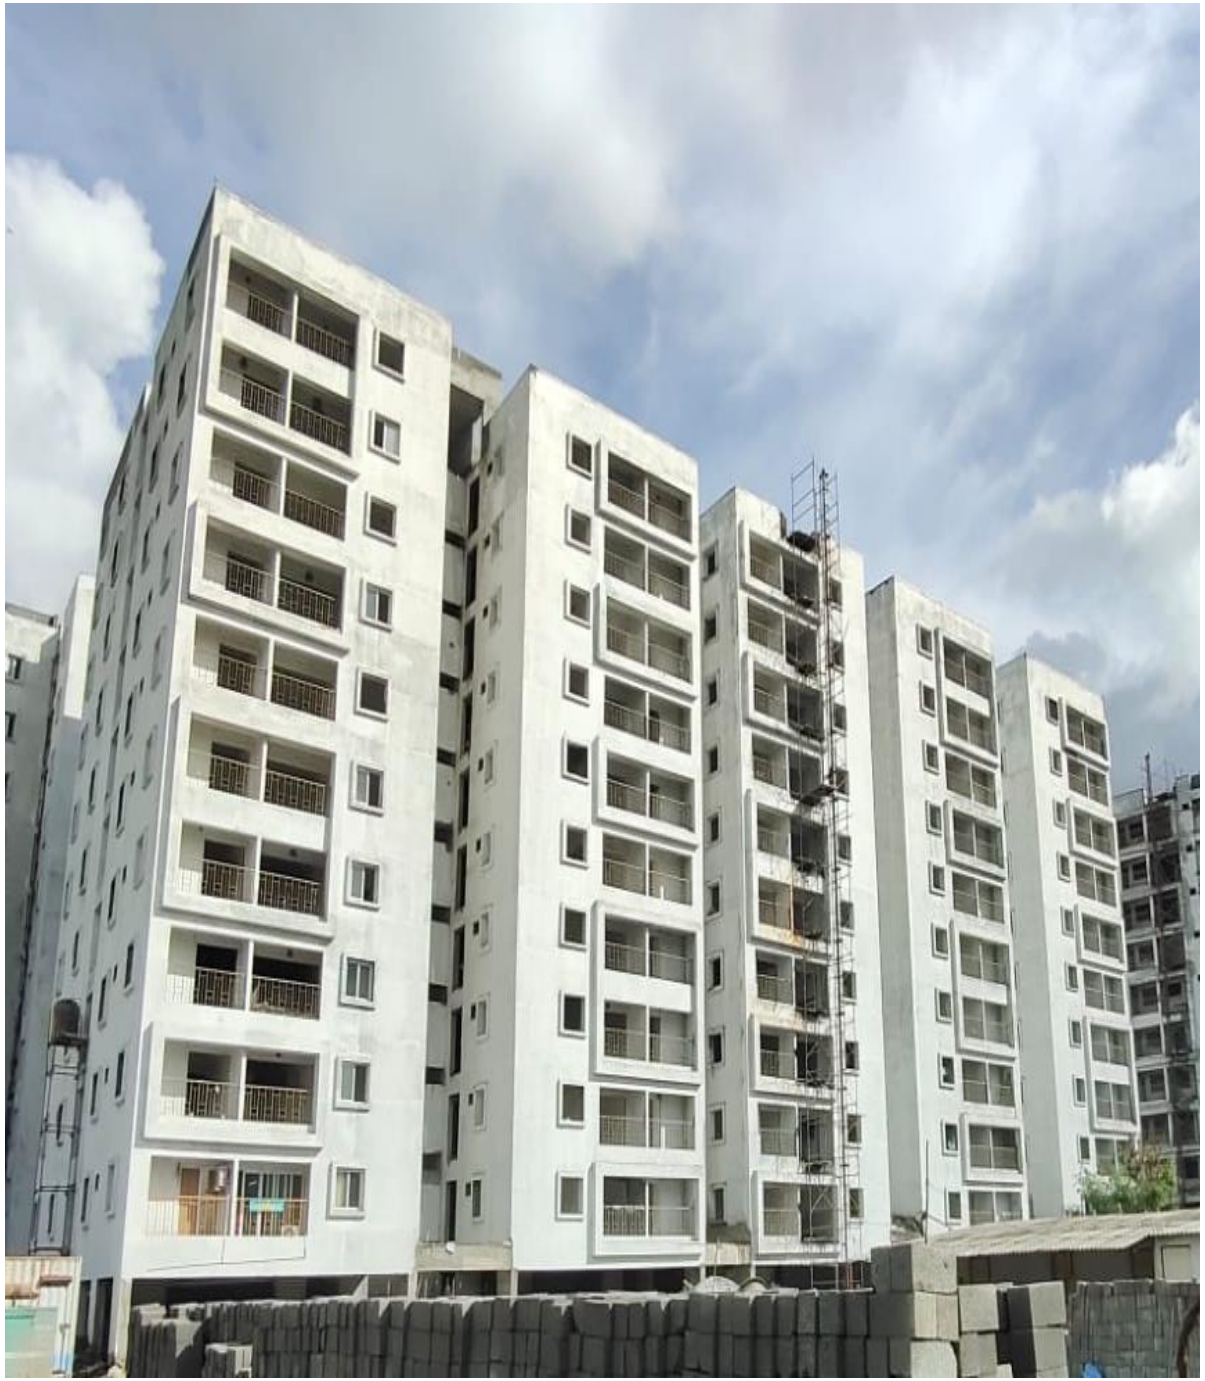
Block C3: External Plastering completed. Fixing of UPVC Windows & Laying of Floor Tiles on progress.

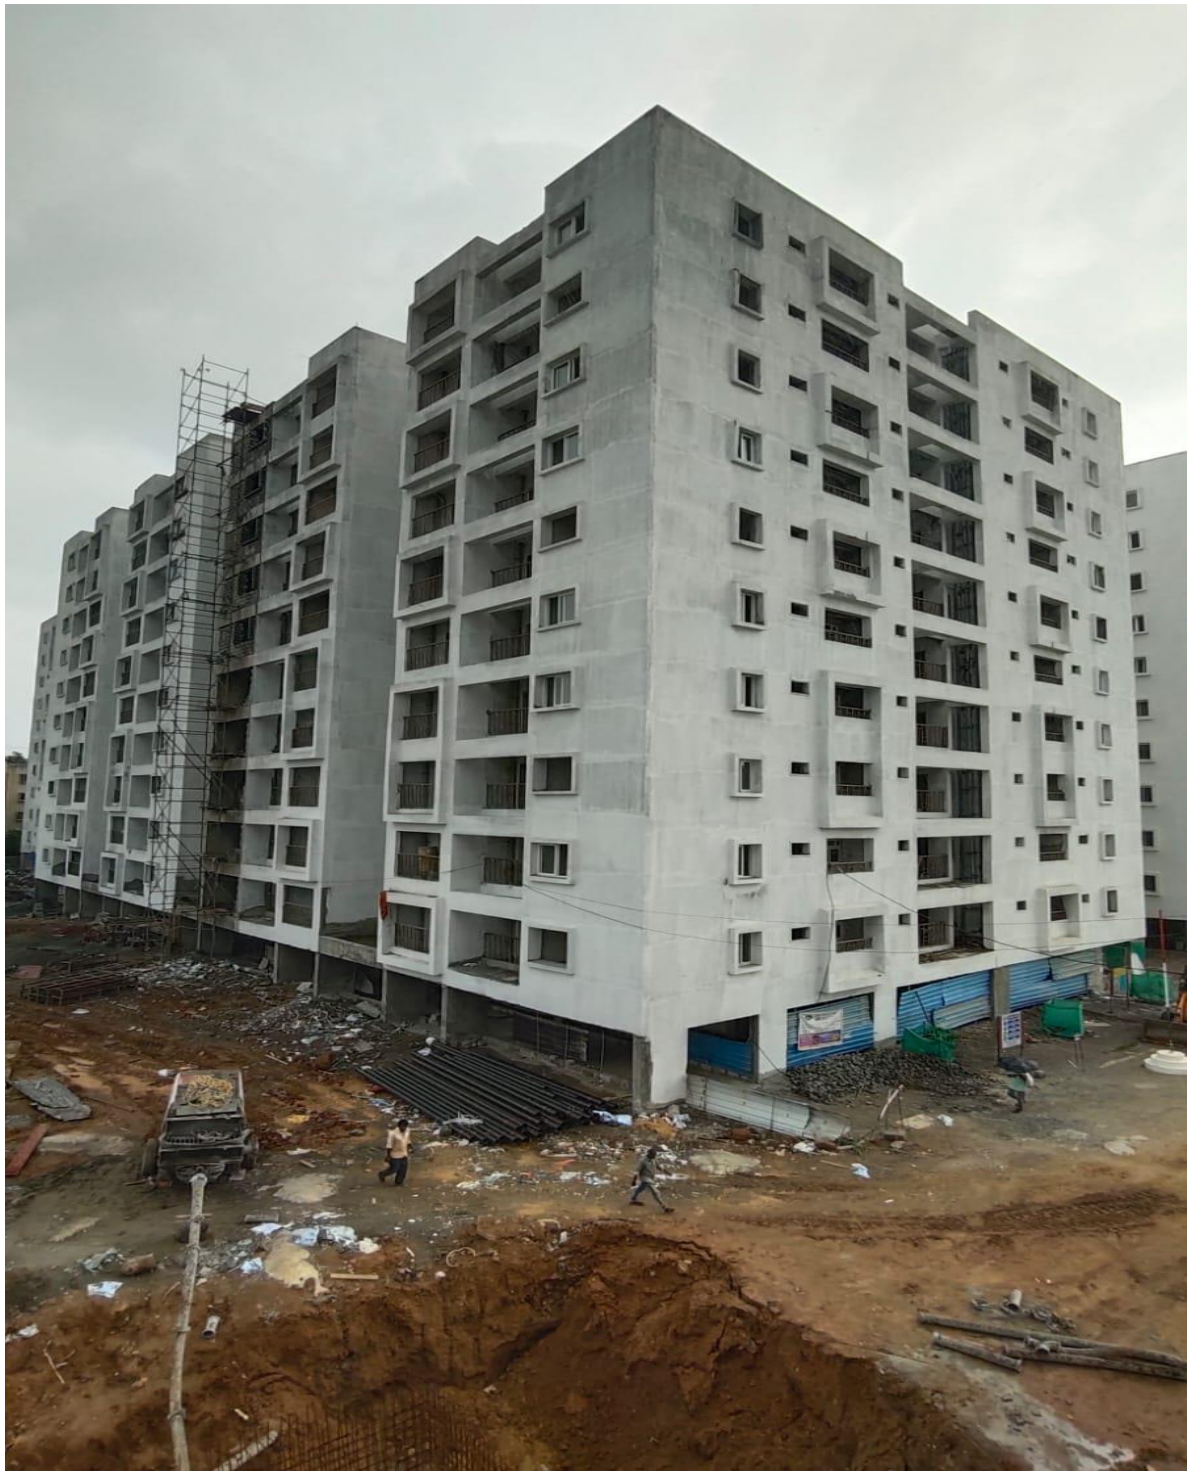
Block D1: External plastering overall 95% completed. Fixing of UPVC Windows & Laying of Floor Tiles on progress.

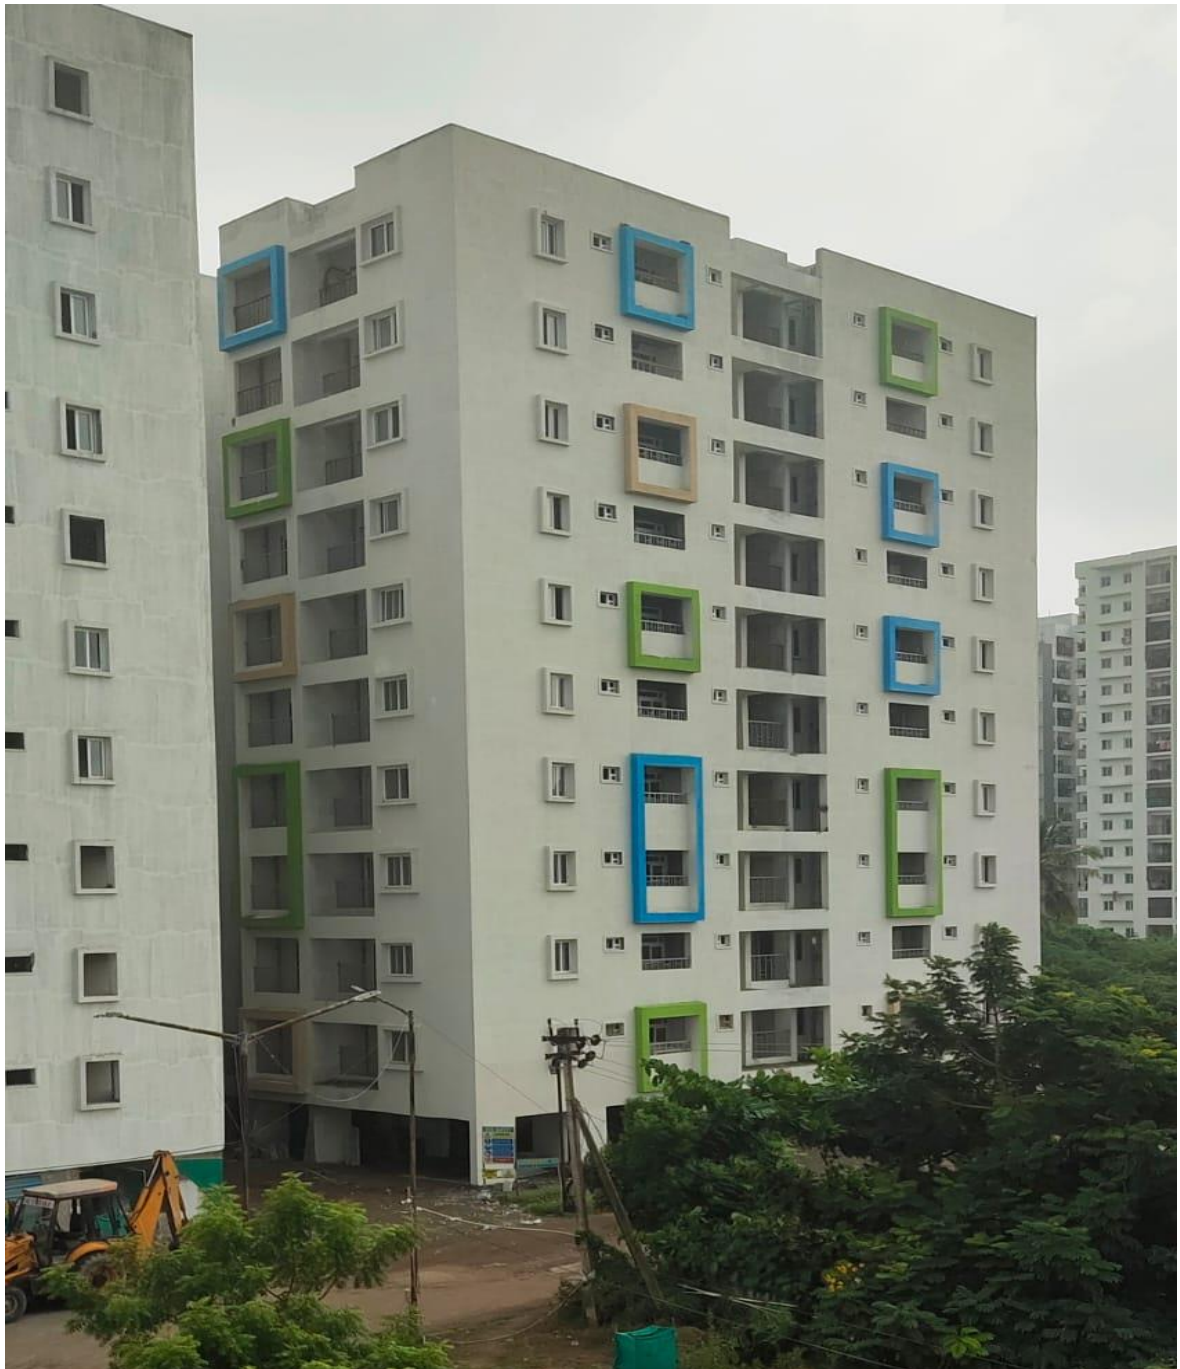
Block D2: Lift installation works 90% completed. Terrace weathering completed. Fixing of M.S Safety Grill for windows on progress.

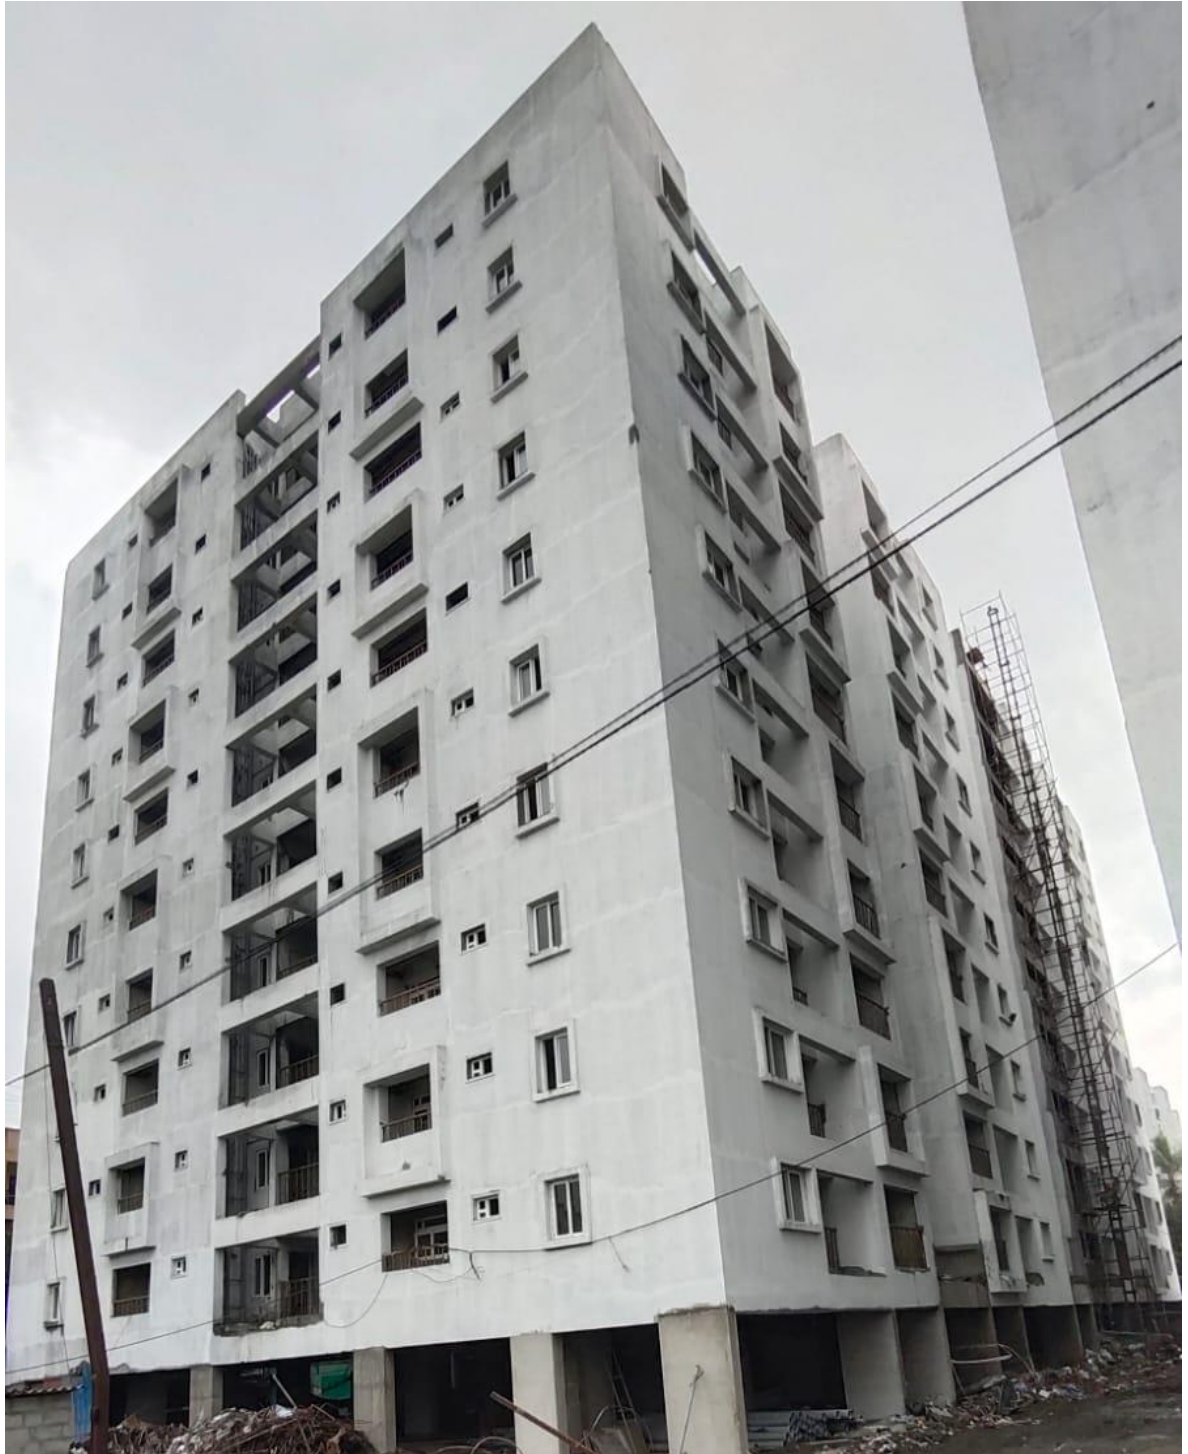
Block D3: External Plastering work overall completed. Fixing of UPVC Windows & Laying of Floor Tiles on progress.

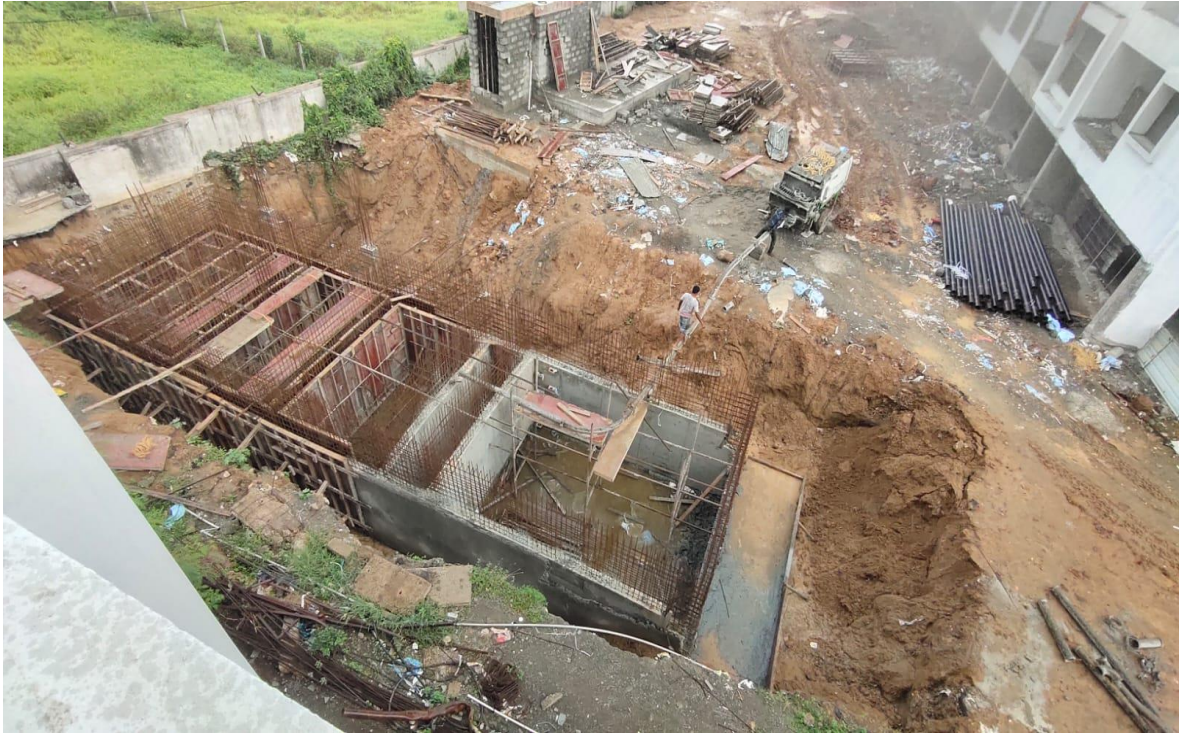
Sewage Treatment Plant 1 – Base Slab RCC completed. Wall Concrete 45% completed and balance works on progress.

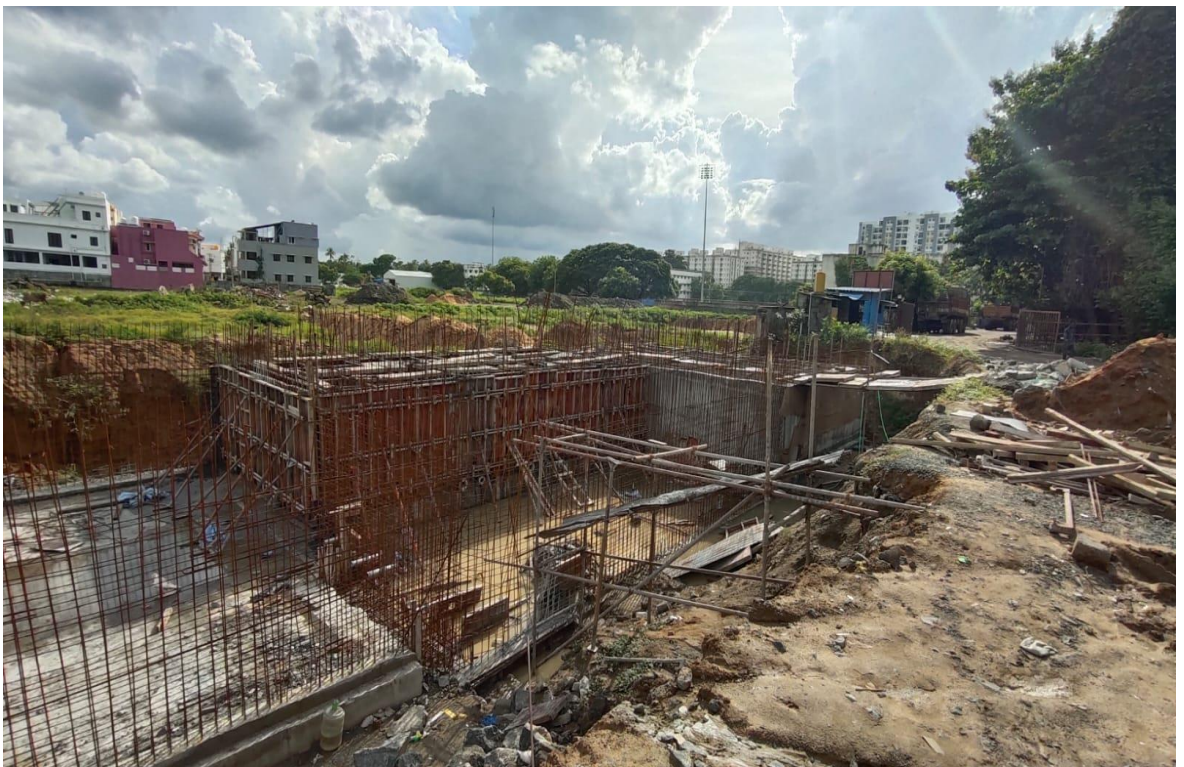
Sump 1 – Base Slab RCC 95% completed. Sump wall Concrete 40% completed and balance works on progress.
