# Quality Inspection Report

March 2013

for Central Government  
Employees Welfare  
Housing Organisation (CGEWHO)

by Housing & Urban  
Development Corporation Ltd.,  
Consultancy Wing , Chennai

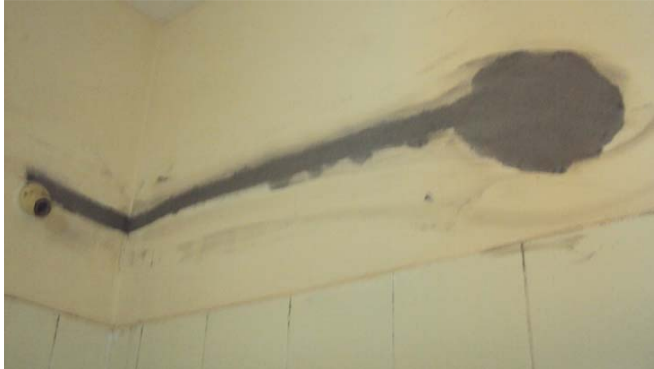
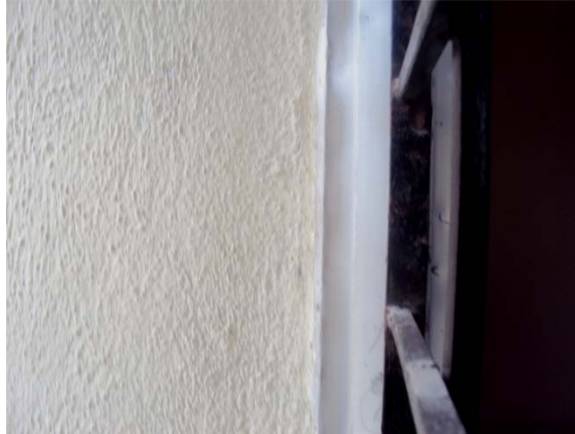
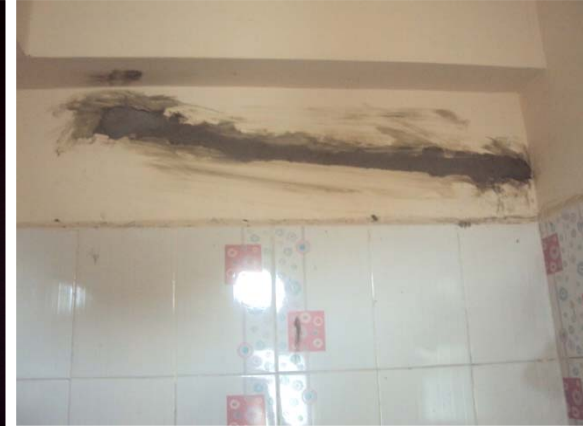
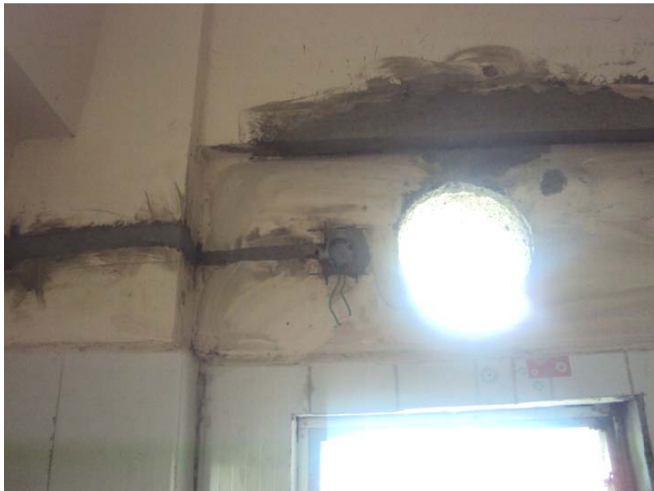
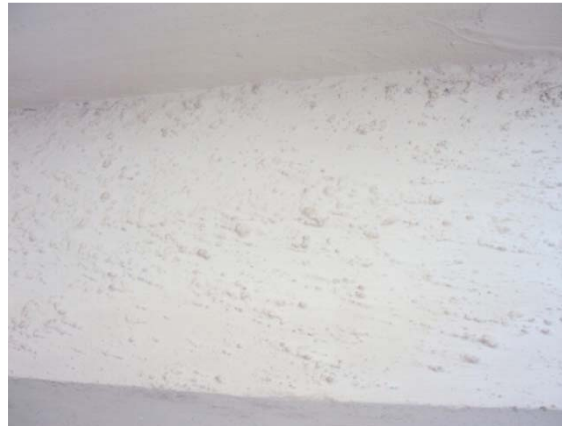
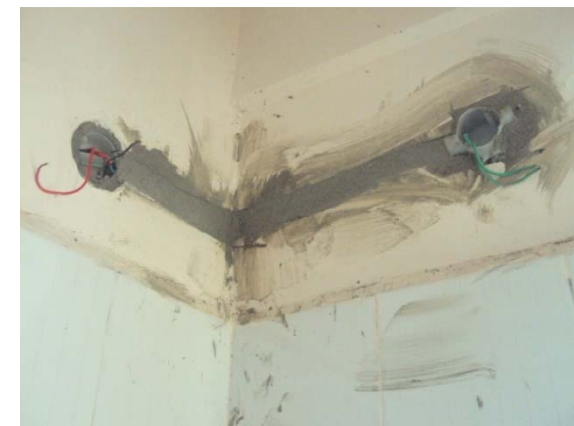
## Painting, plastering and finishing

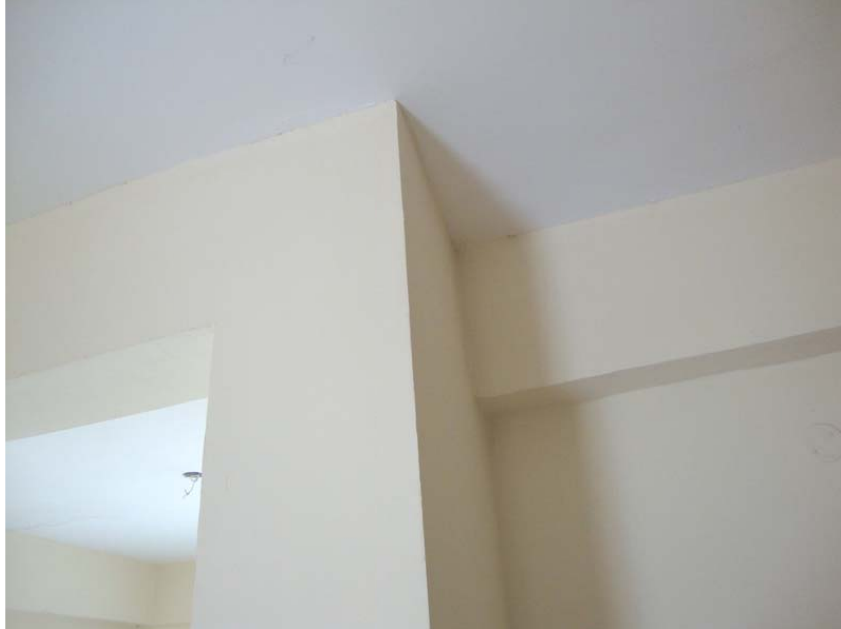
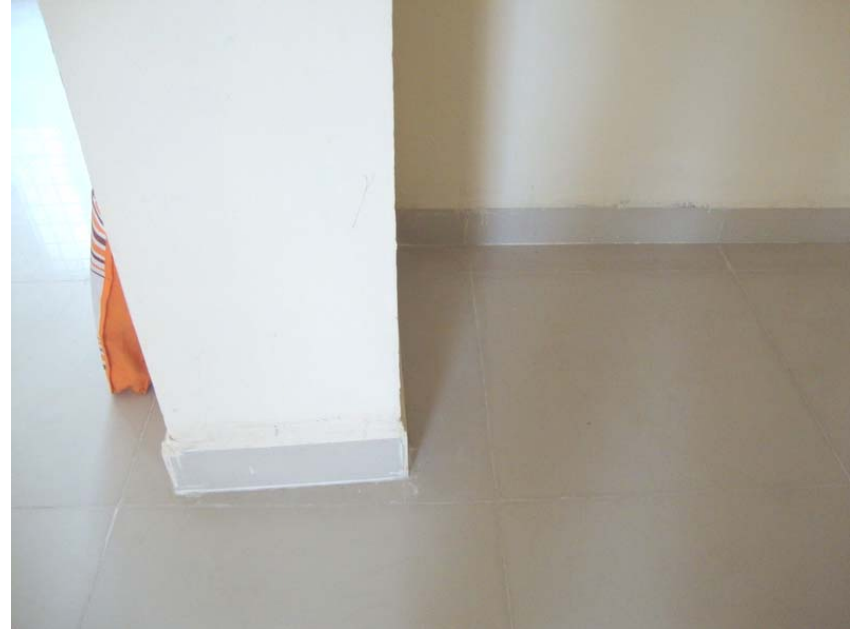
## Walls skew/not plumb

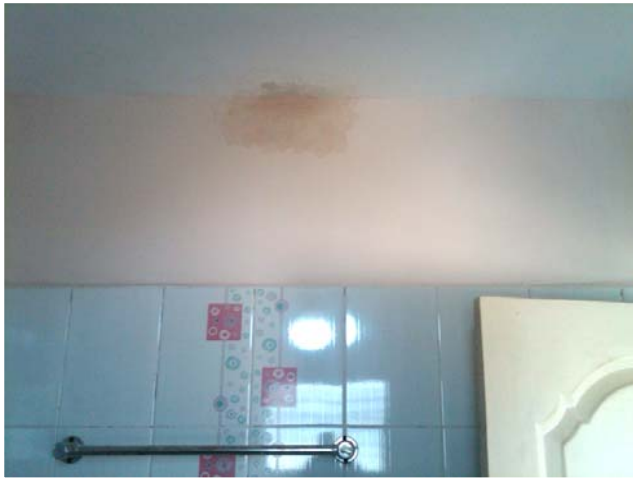
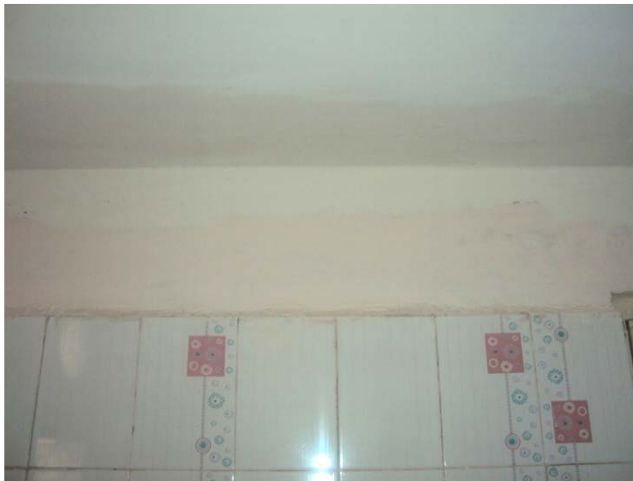
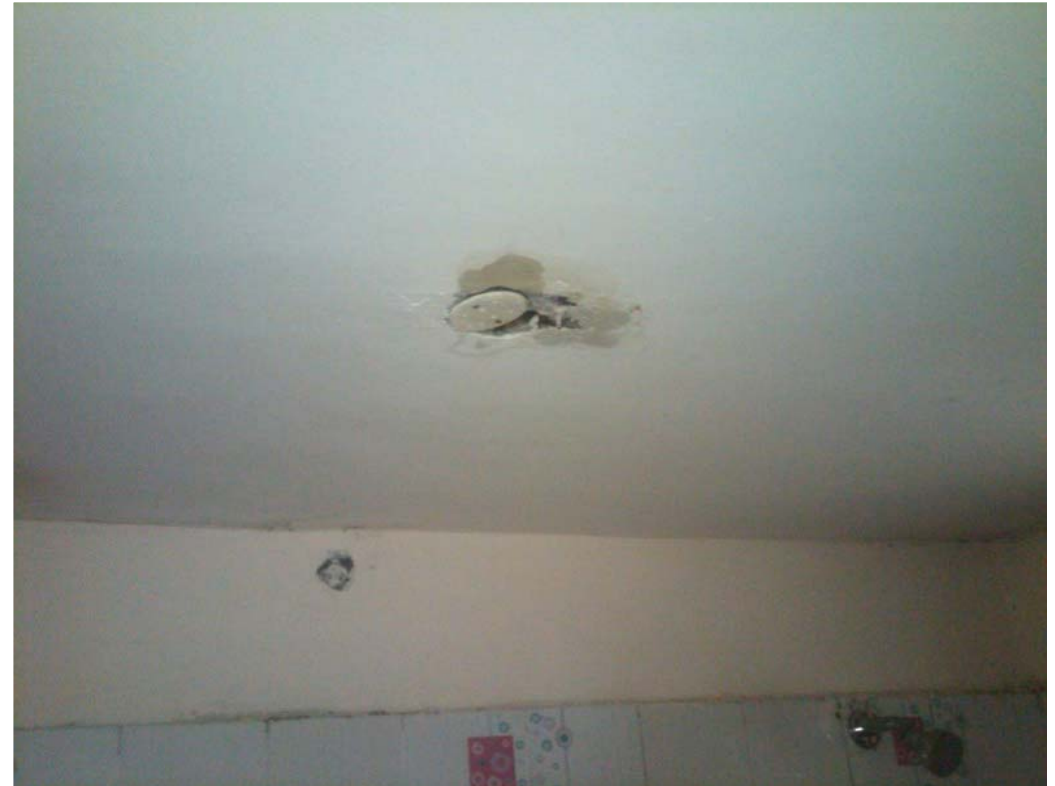
## Ceiling not horizontal/undulating/sloping

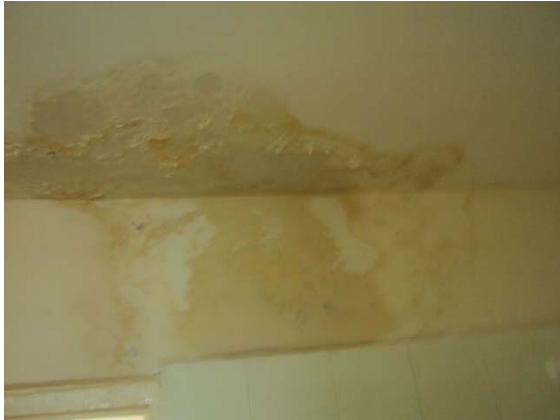
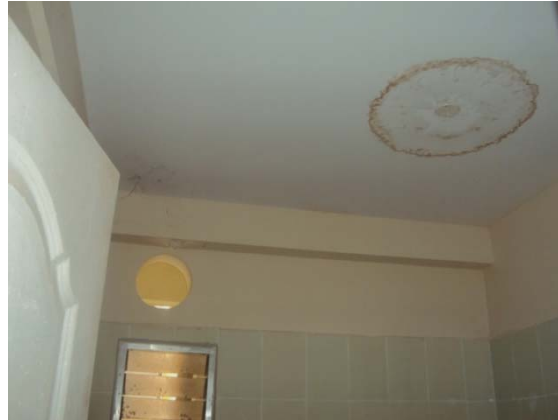
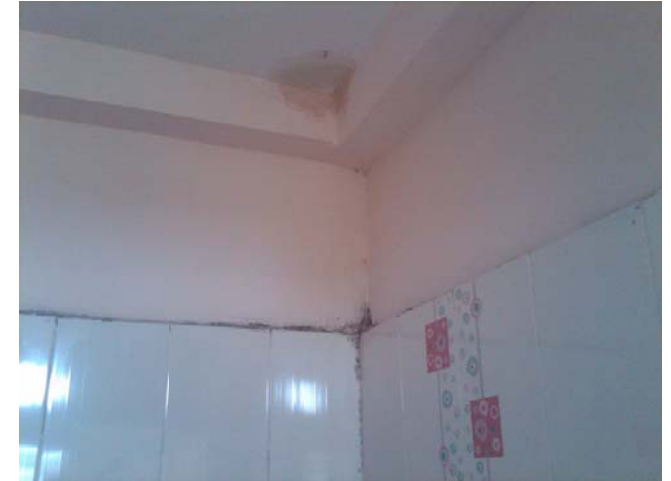
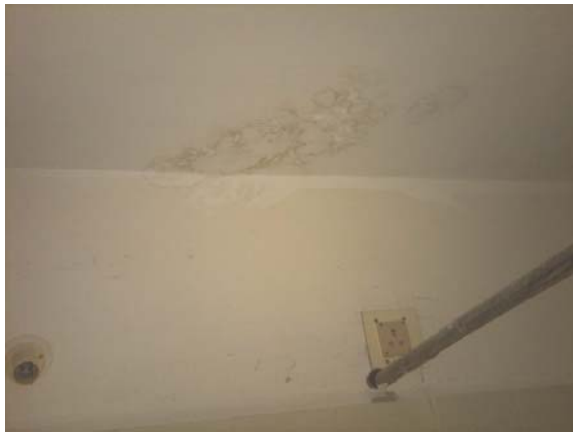
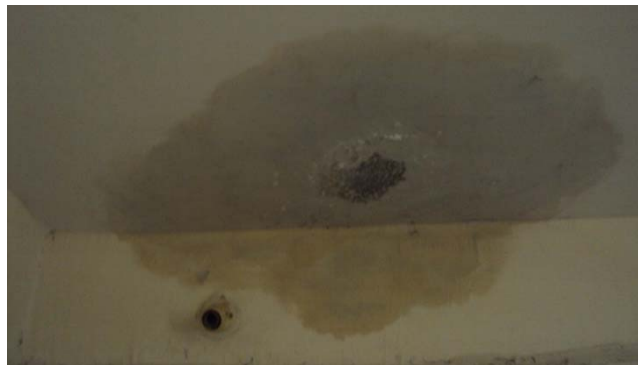
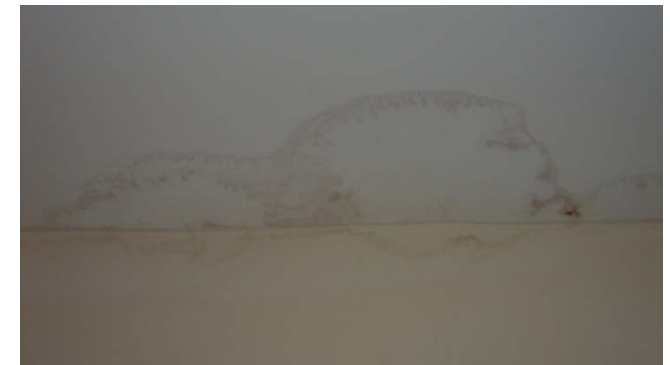
## Dampness in ceiling

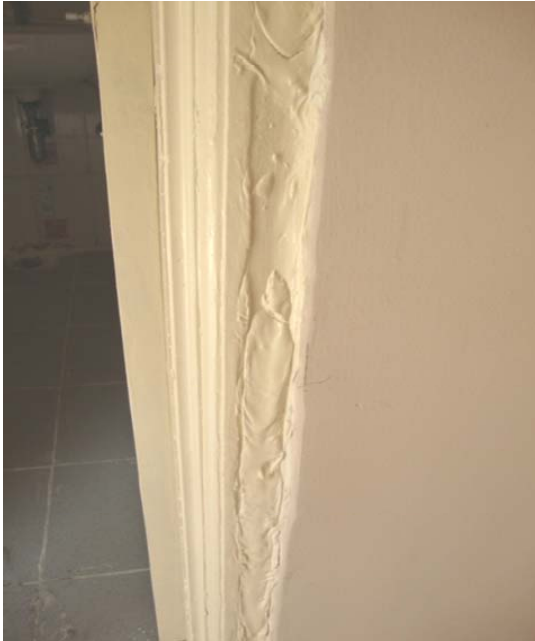
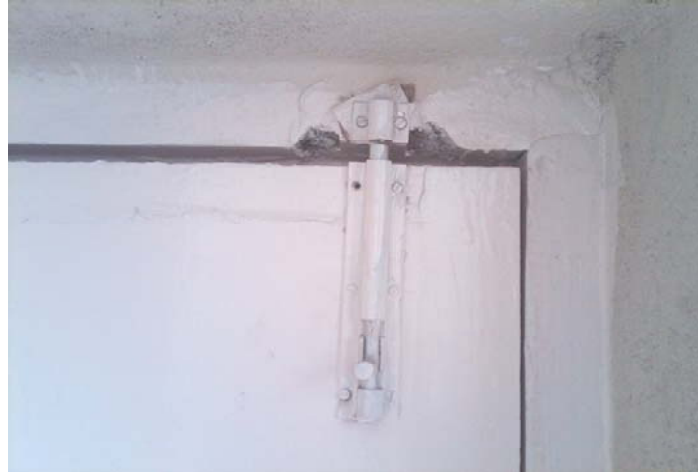
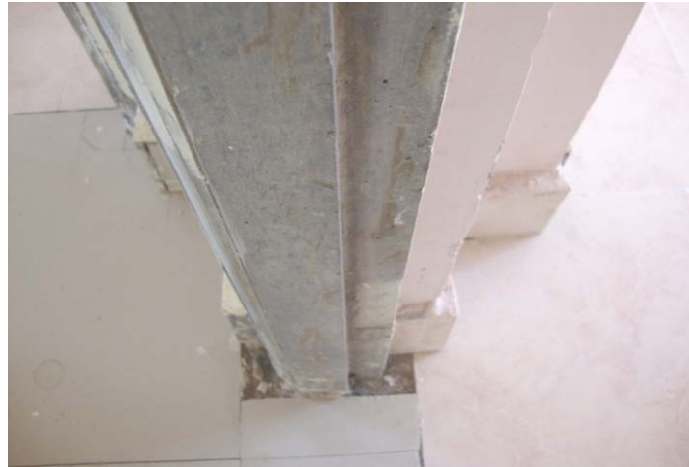
## Door Frame

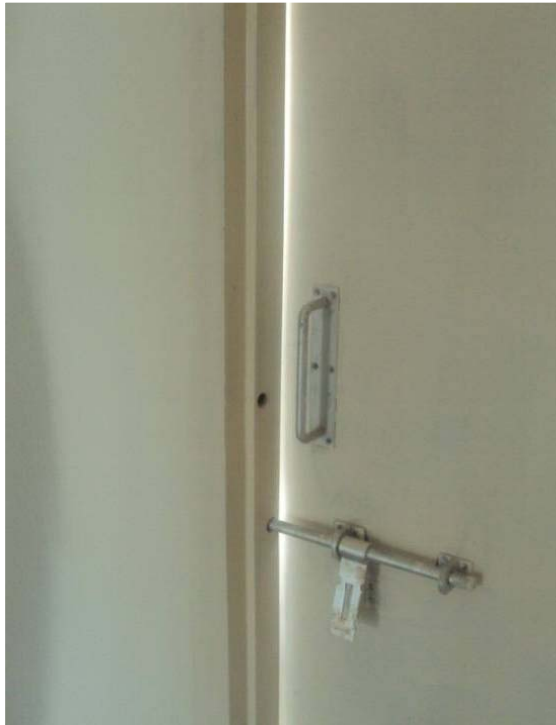
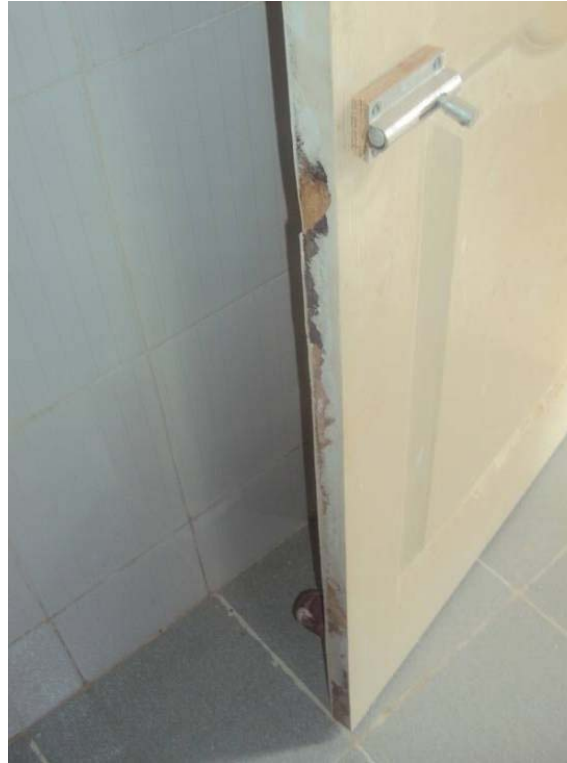
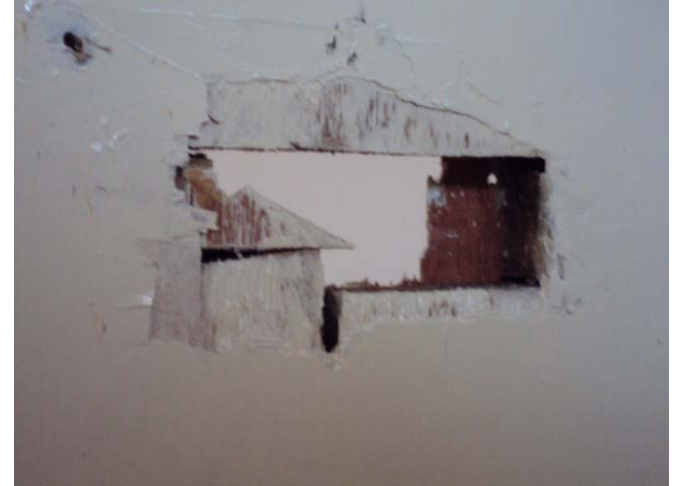
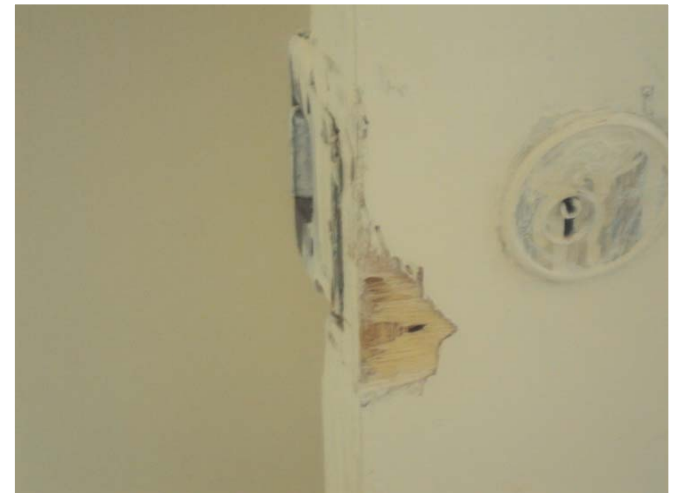
## Door shutter

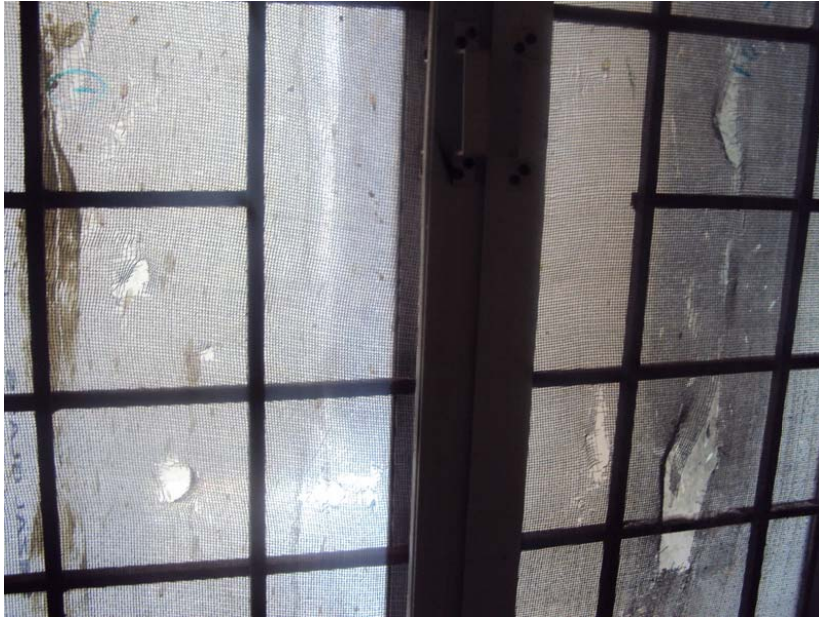
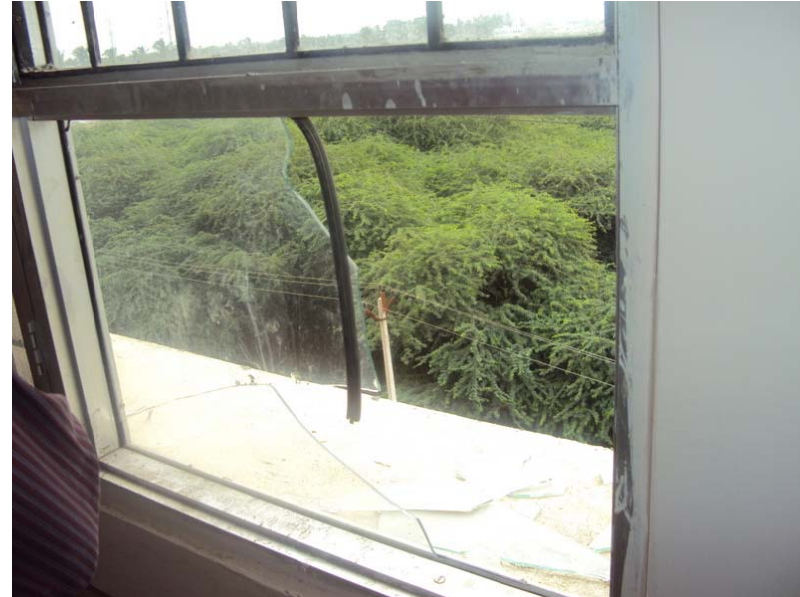
## Window grill/mesh

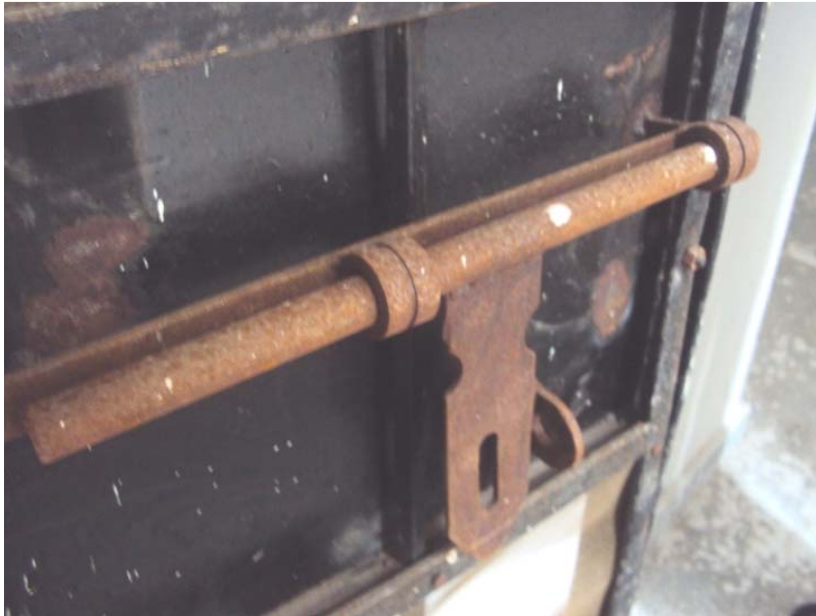
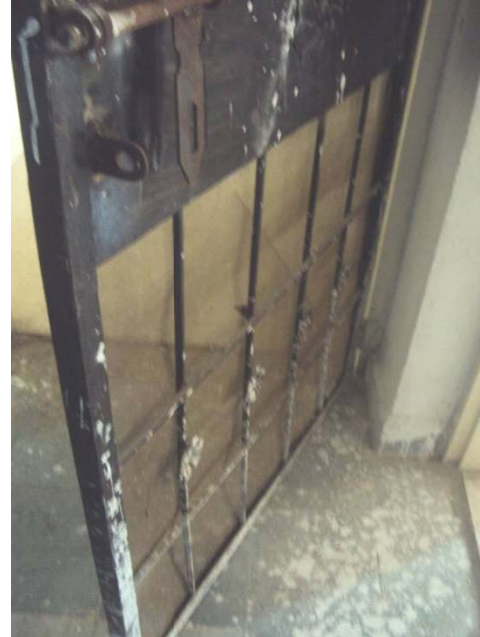
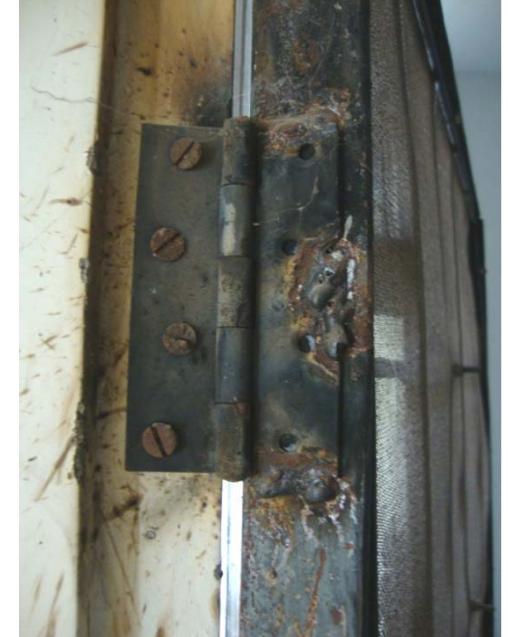
## Grill door

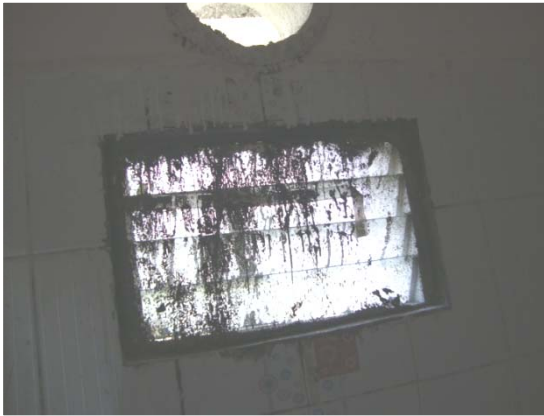
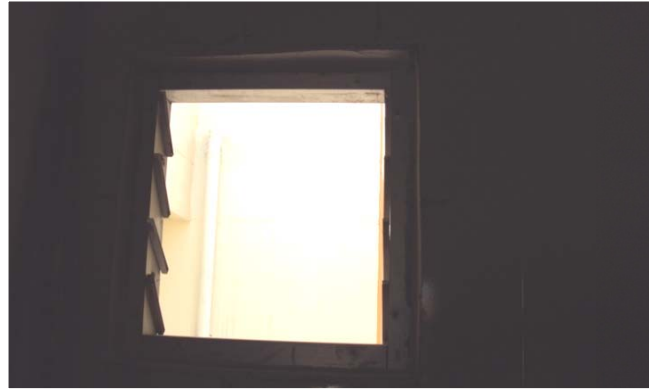
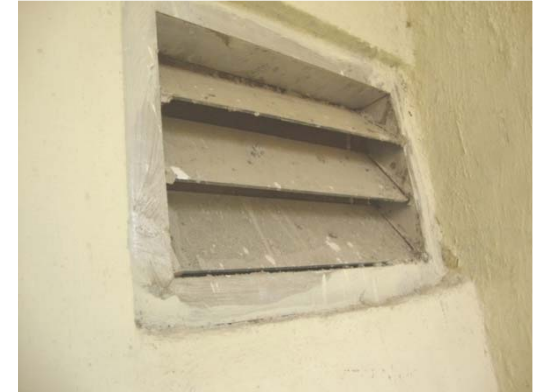
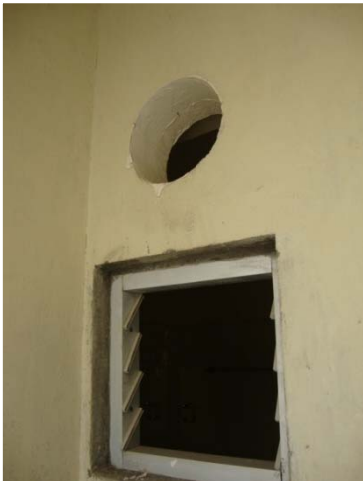
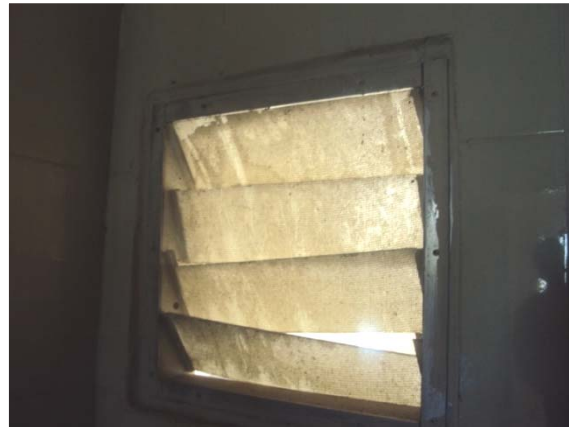
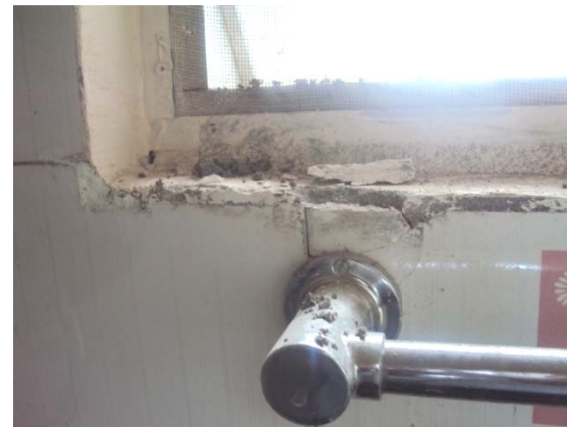
## Ventilator

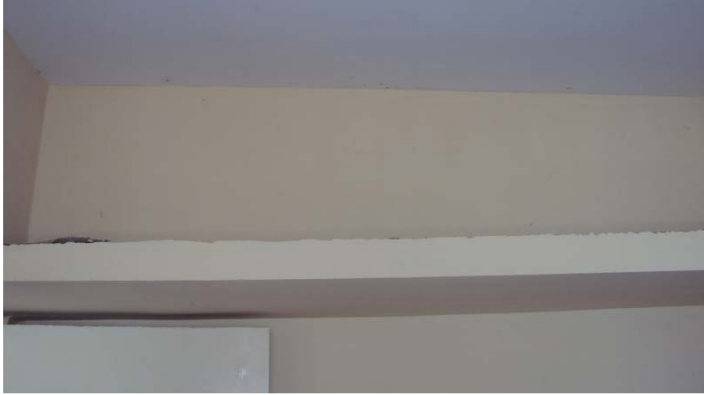
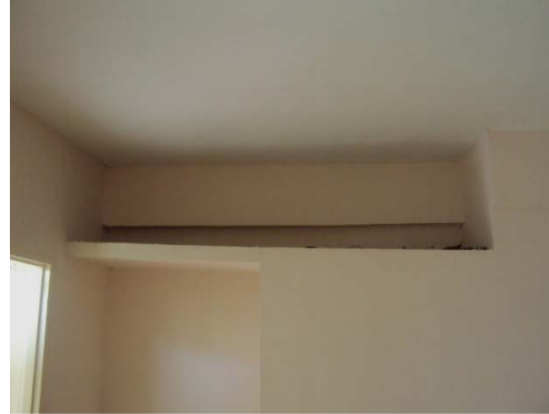
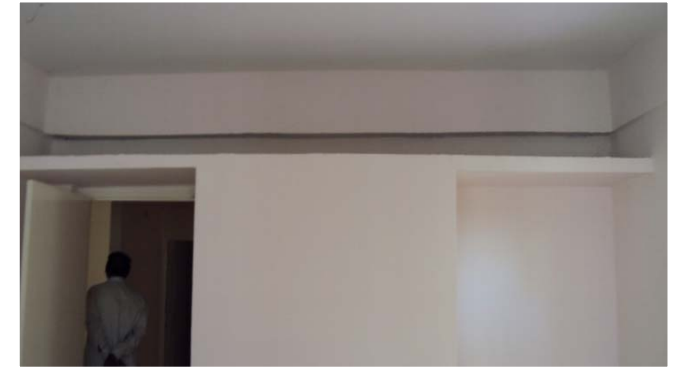
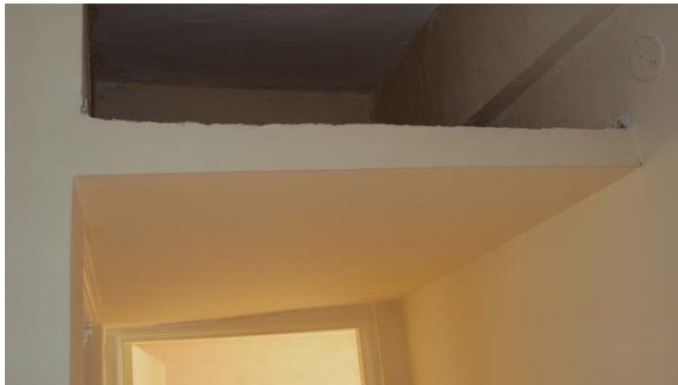
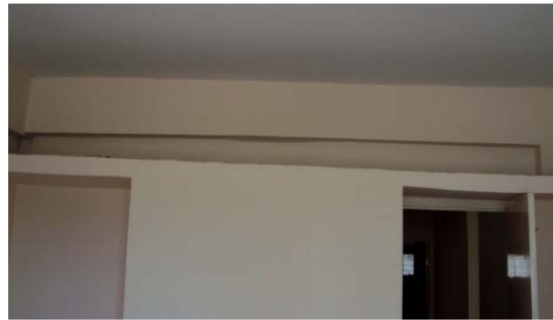
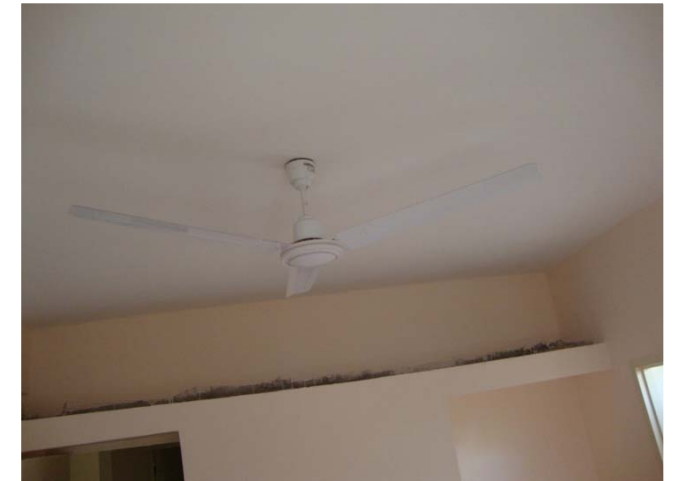
## Loft not level

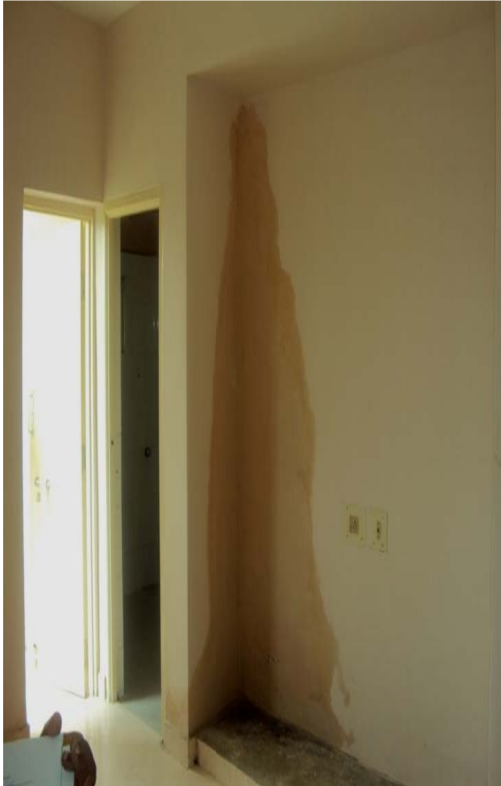
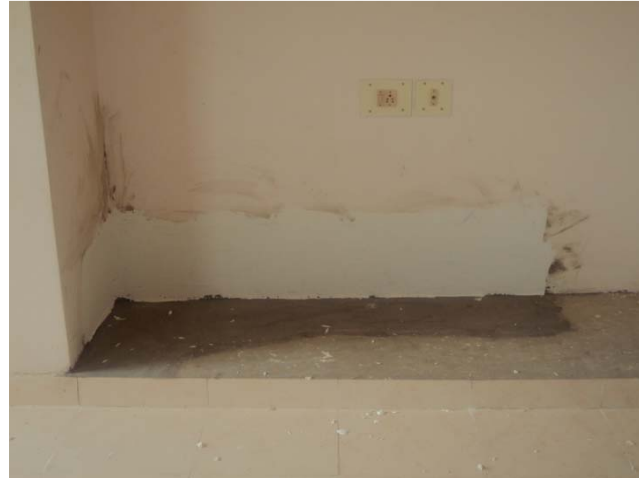
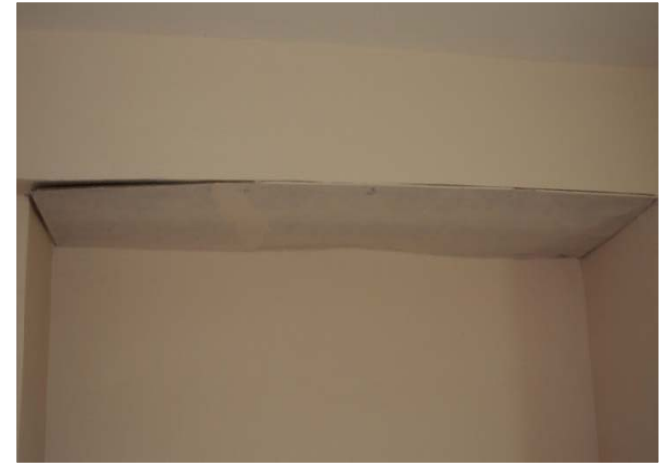
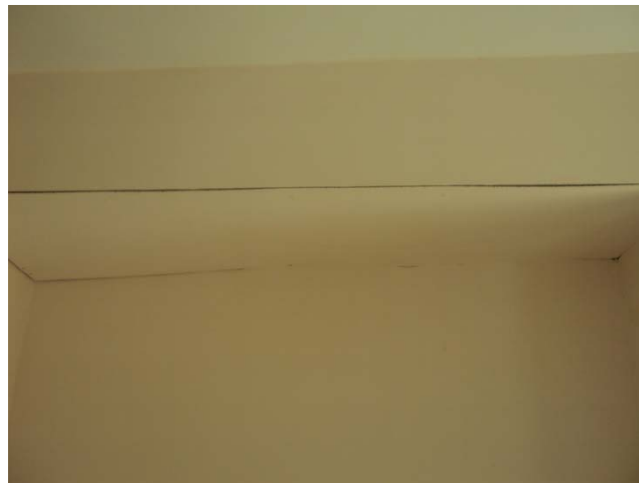
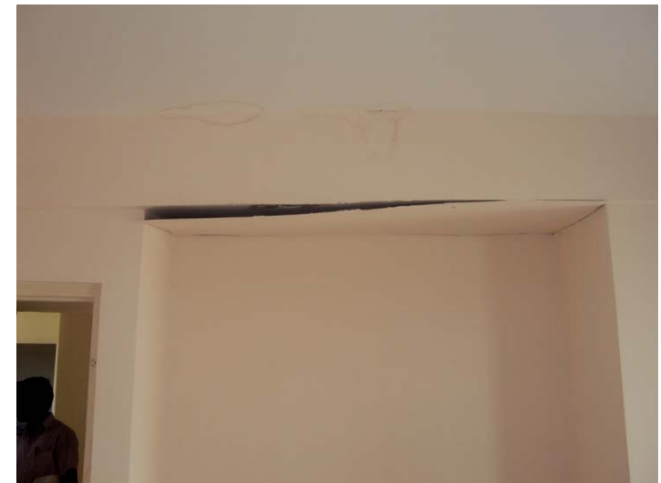
## Cupboard

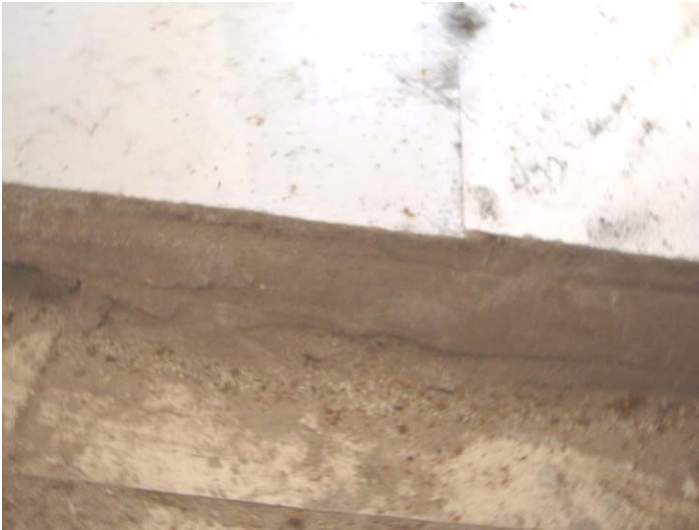
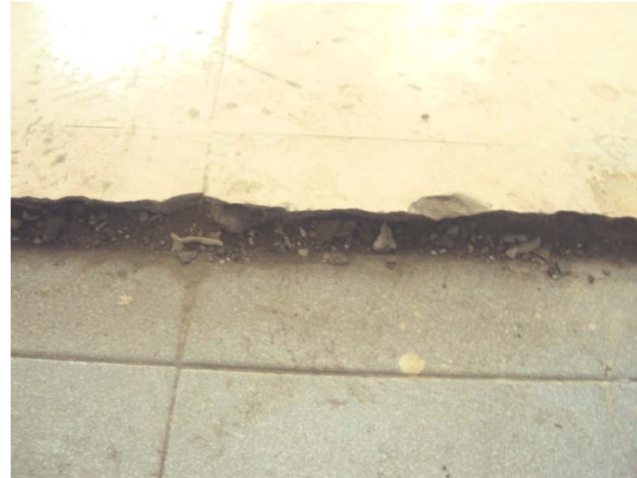
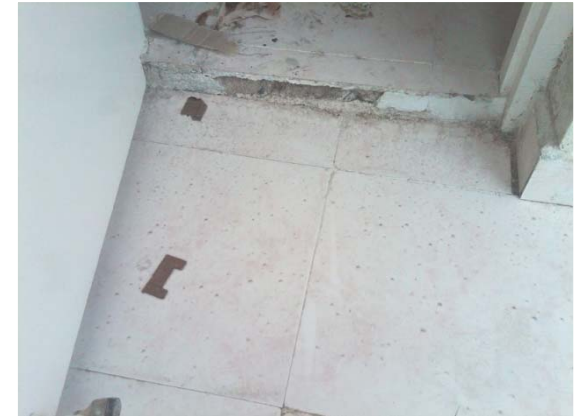
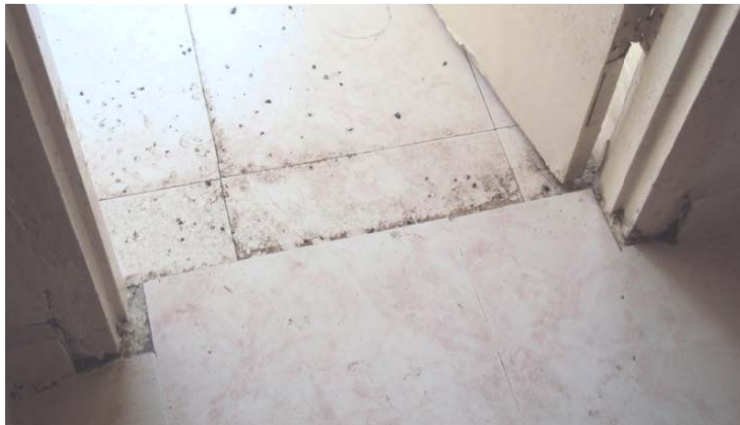
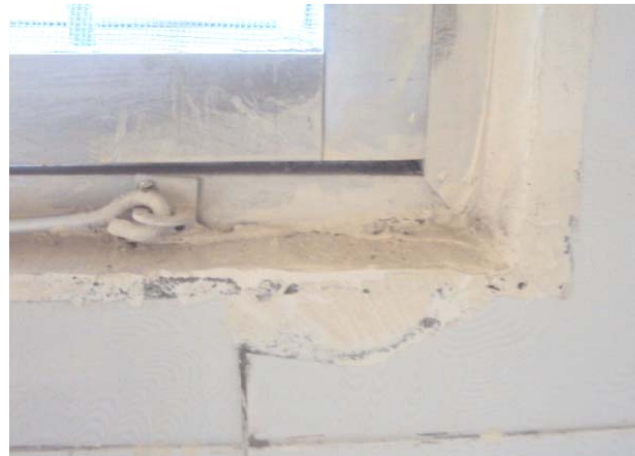
## Sill not finished/not level

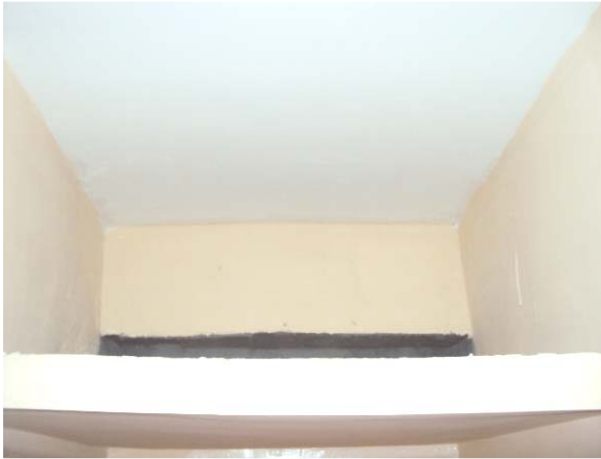
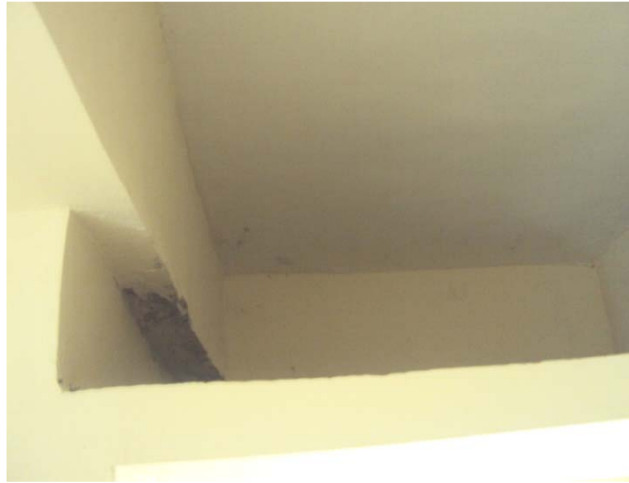
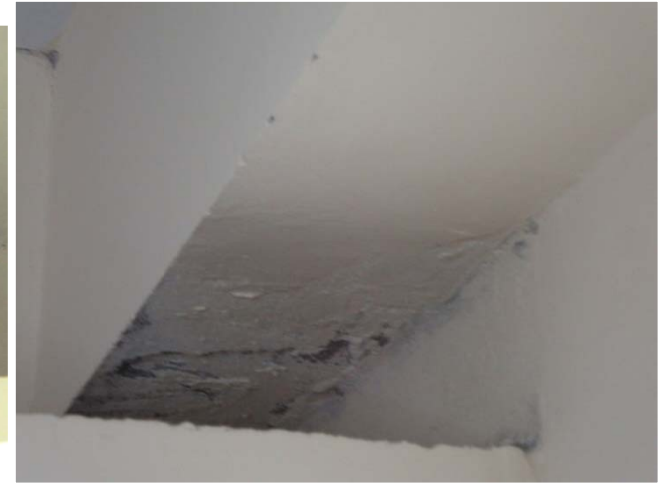
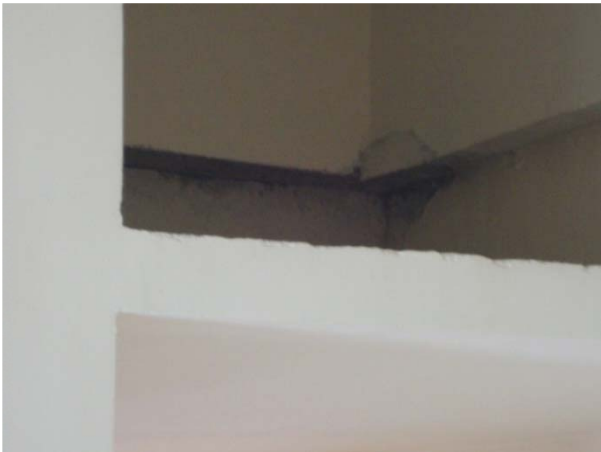
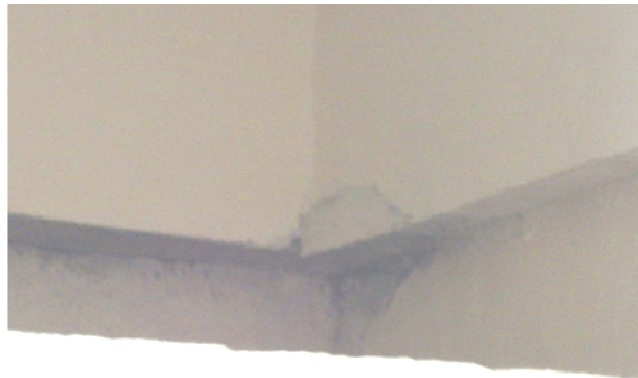
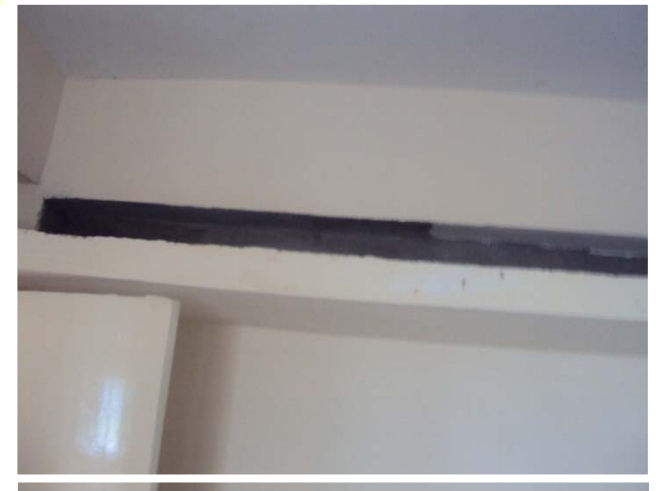
## Loft not finished

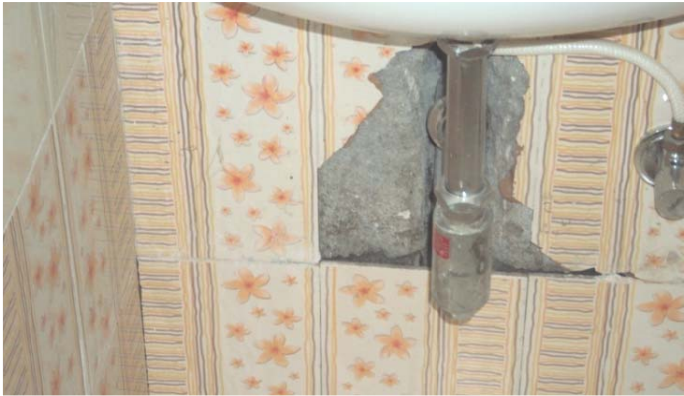
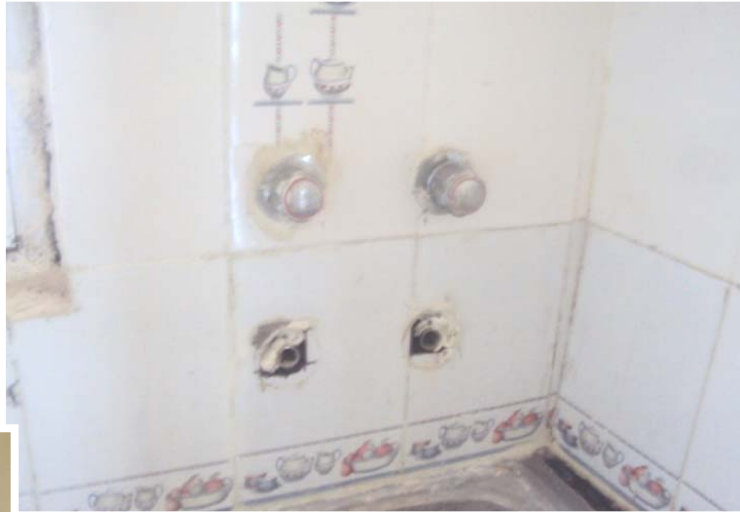
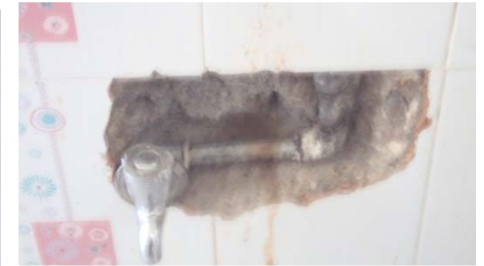
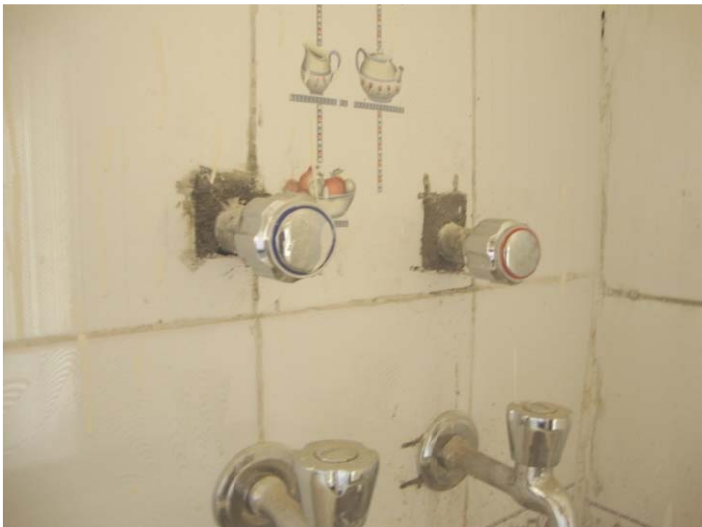
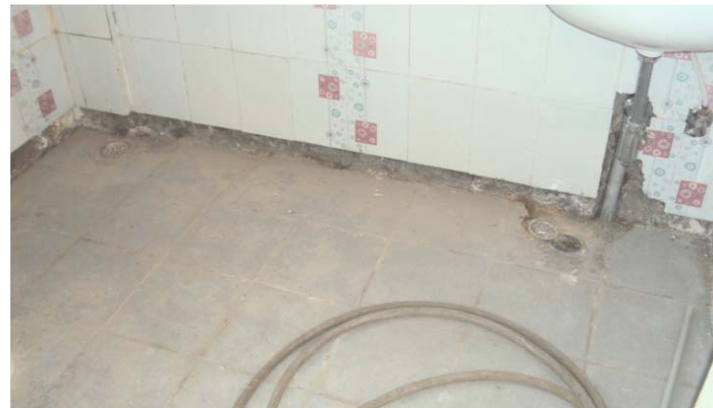
## Plumbing fixtures

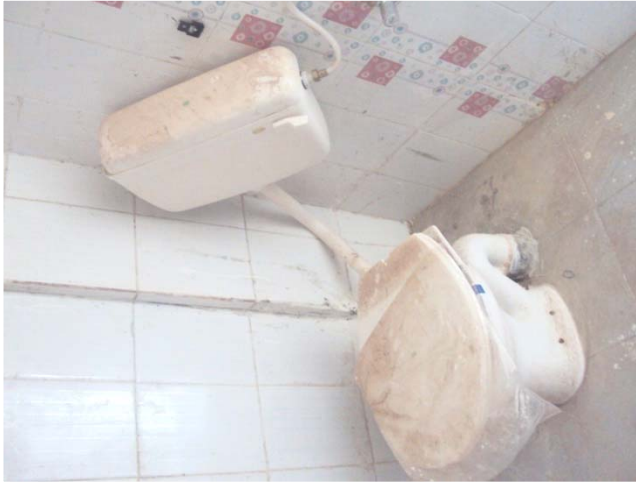
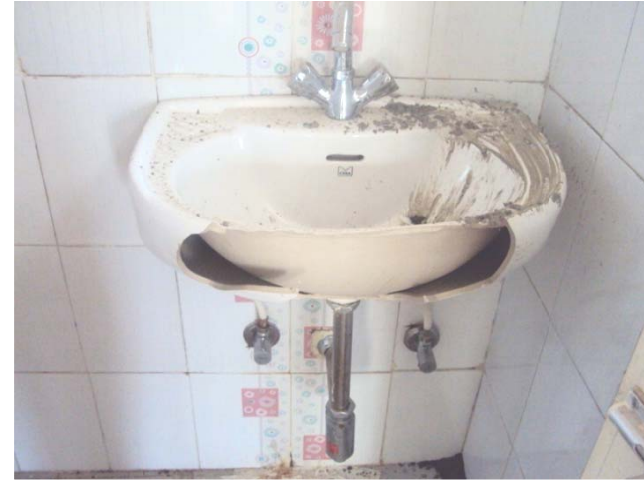
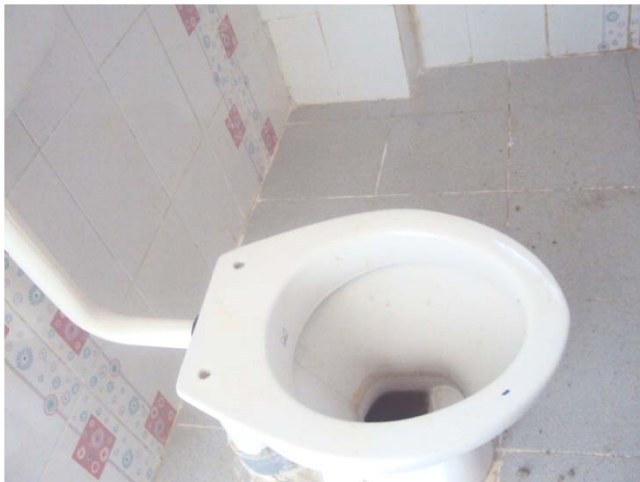
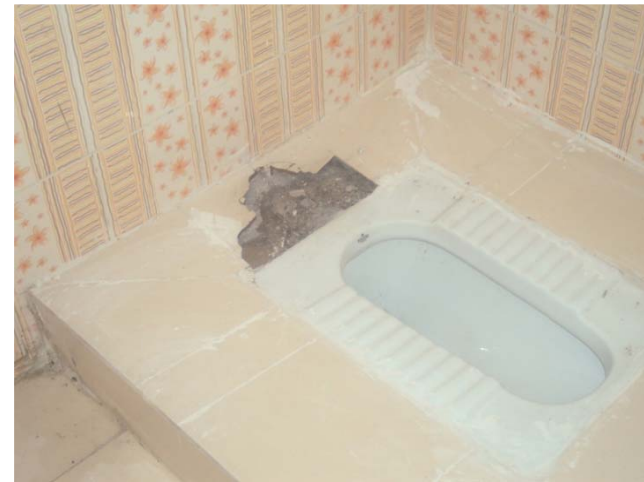
## Sanitary fitting and fixtures

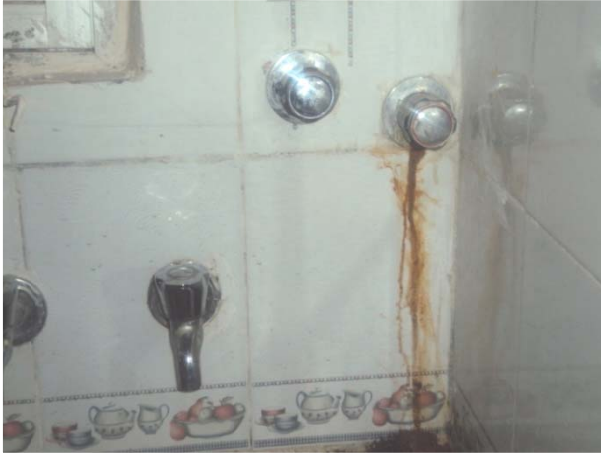
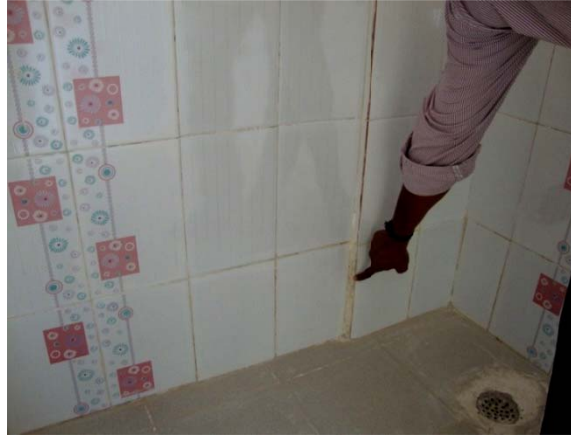
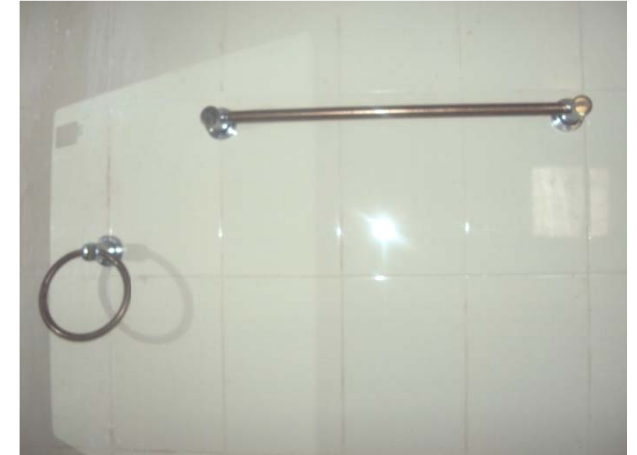
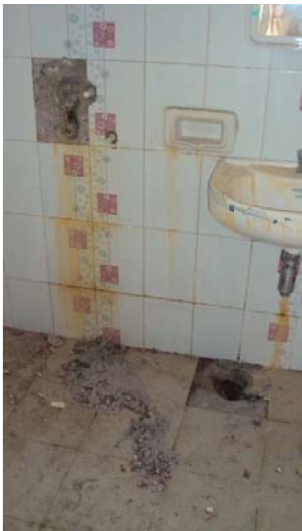
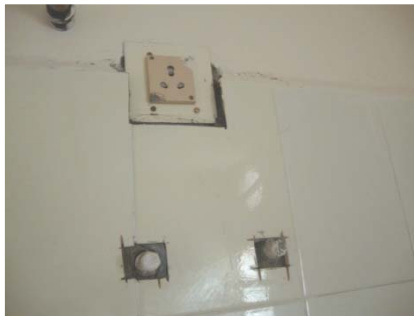
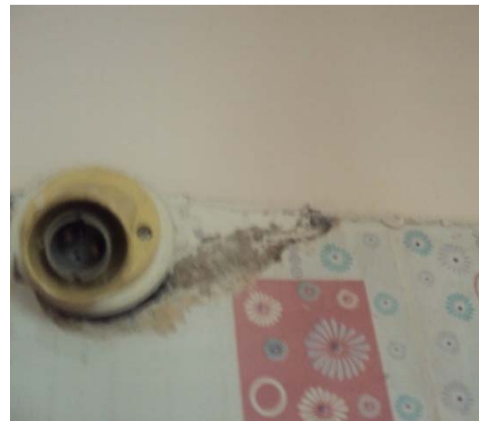
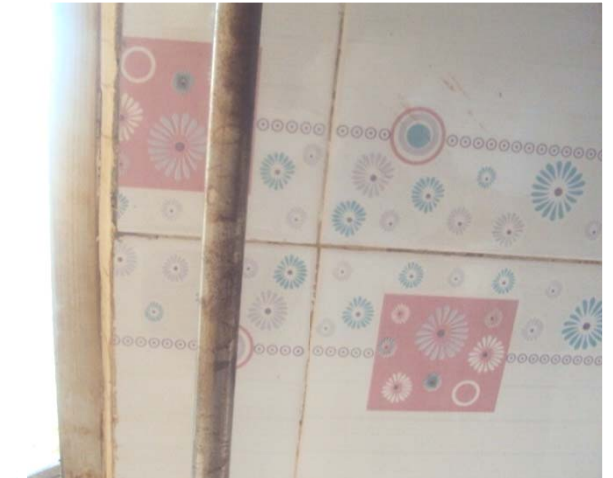
## Bathroom tiles

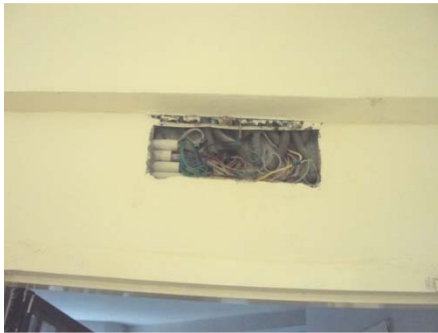
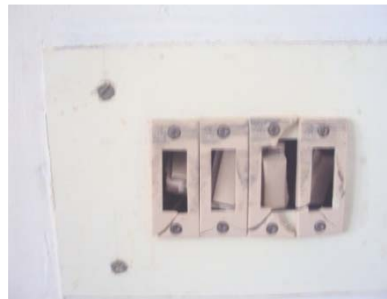
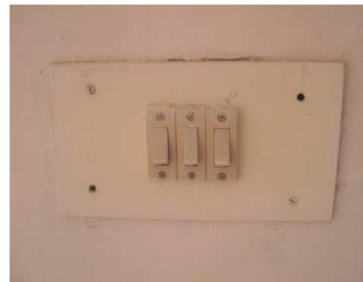
## Electrical
