# Quality Inspection Report

March 2013

for Central Government  
Employees Welfare  
Housing Organisation (CGEWHO)

by Housing & Urban  
Development Corporation Ltd.,  
Consultancy Wing , Chennai

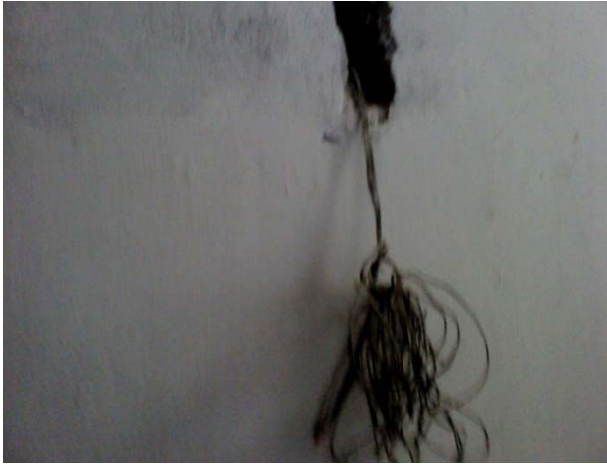
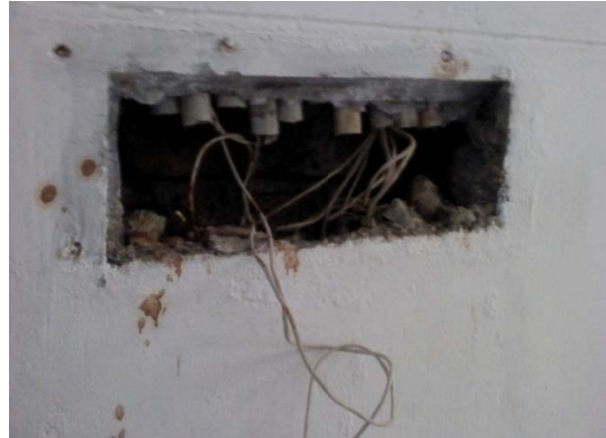
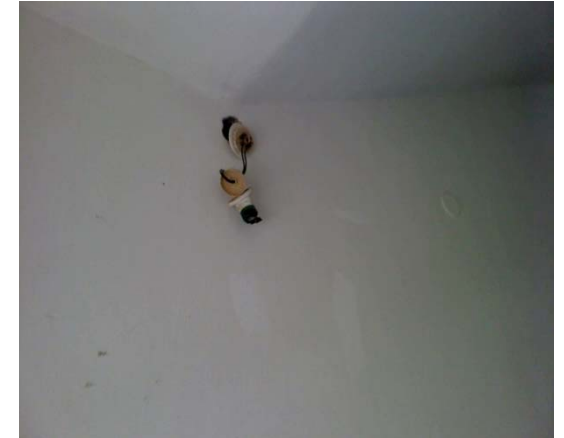
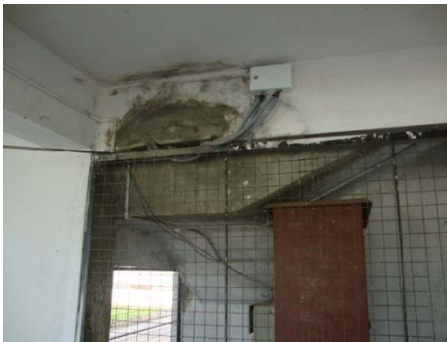
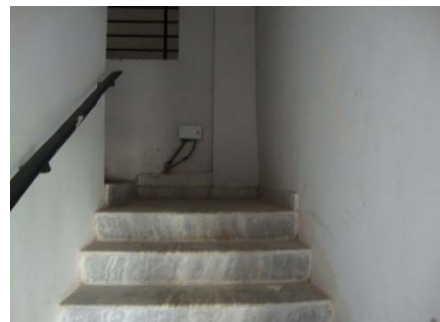
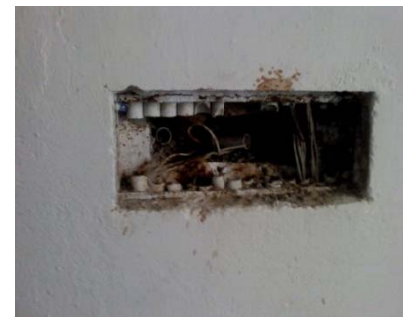
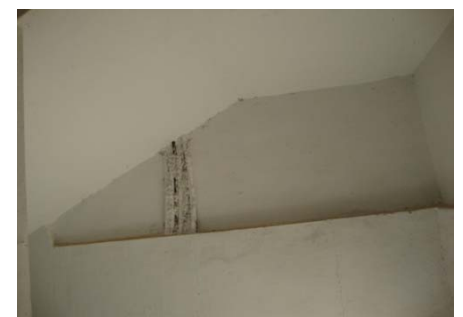
**Drain pipes: Not aligned/placed/anchored and Poor alignment/incorrect joining of SCI pipes**

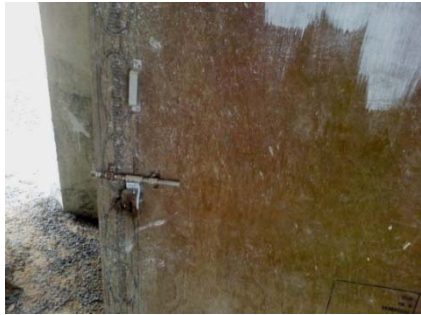
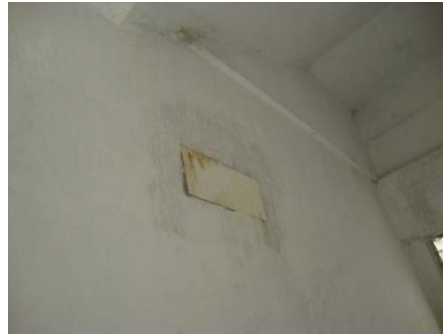
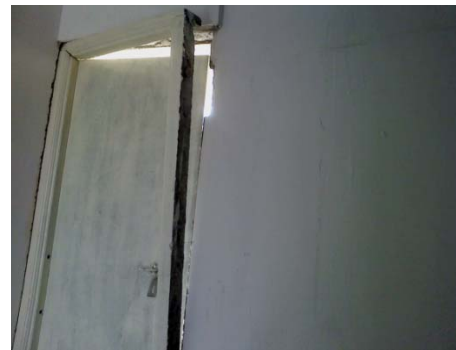
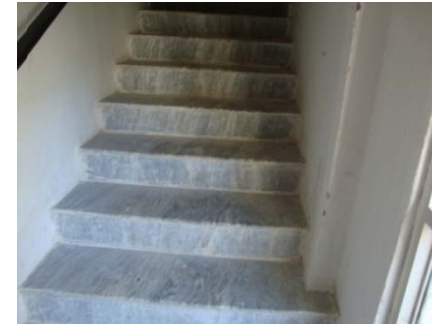
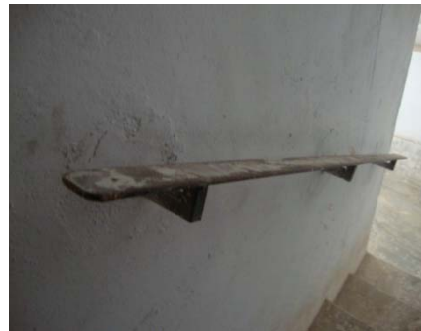
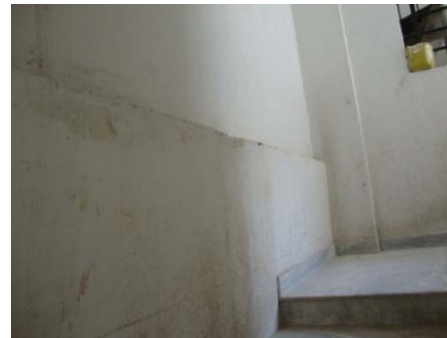
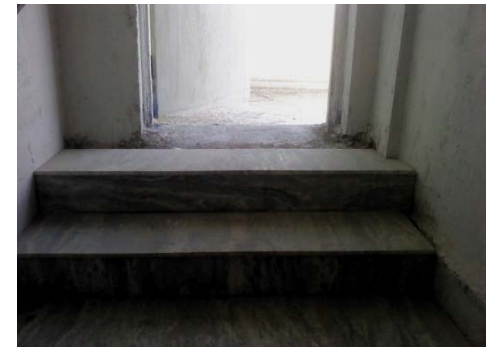
**Lift: Door entry not finished and Inadequate level difference**

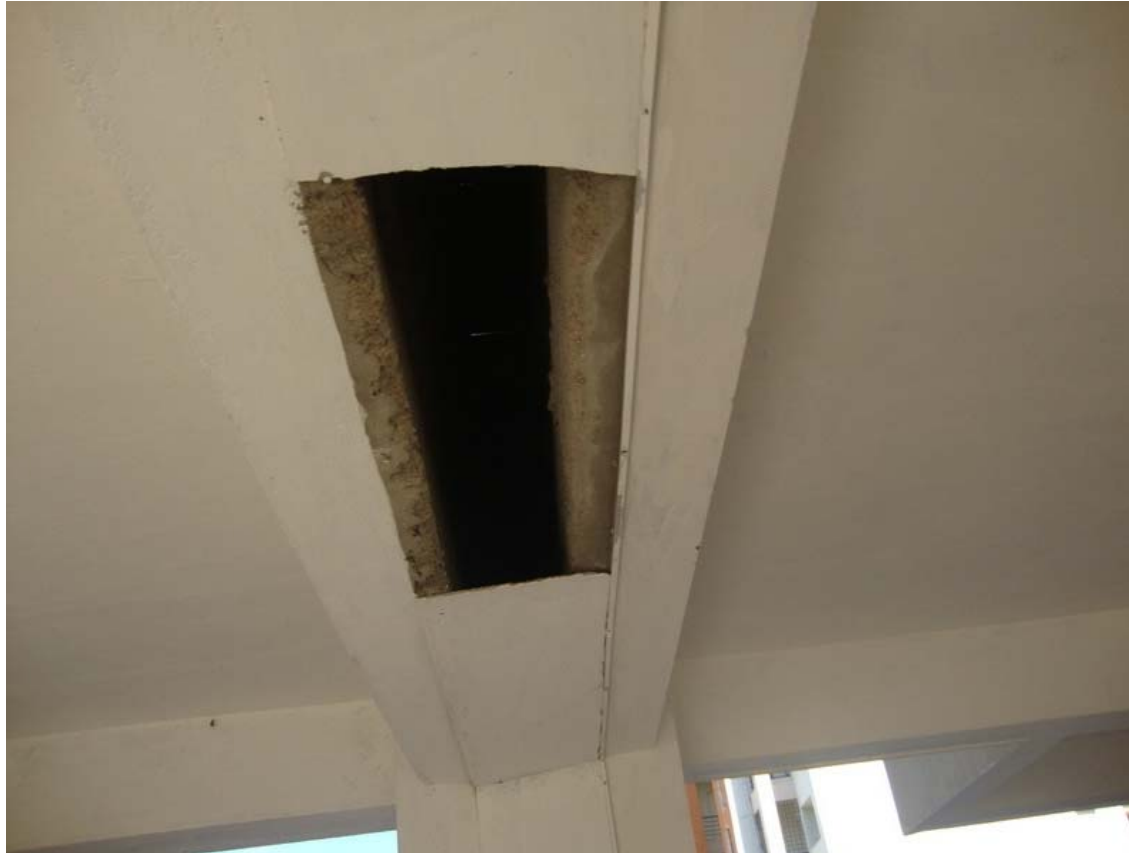
**Expansion Joint: Not covered**
